HMS NOTTINGHAM

FROM WOLF ROCK TO PORTSMOUTH

This is an edited version of the paper that was presented at The Royal Institution of Naval Architects on 6 November 2004

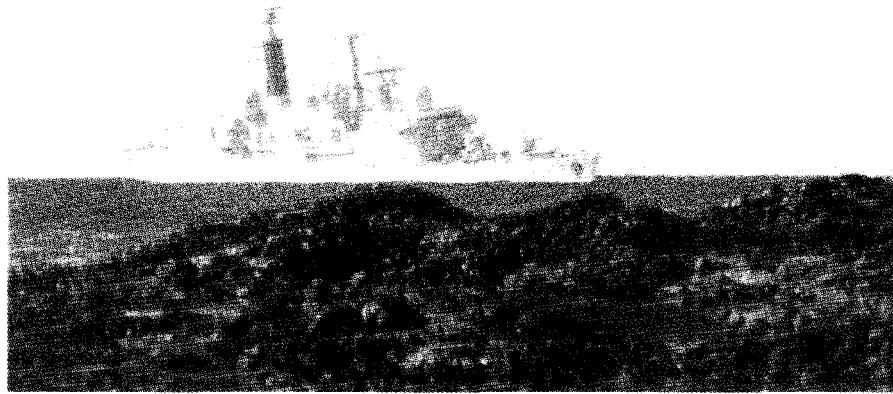
On the 7 July 2002, she was operating alone en route from Cairns, Australia to Dunedin, New Zealand, and had landed a small party (including a CASEVAC) onto Lord Howe Island (LHI) by helicopter. She departed LHI, recovered the helicopter and was manoeuvring to enable helicopter stowage. *Nottingham* grounded on Wolf Rock to the East of LHI at approximately 1300 BST. The ship was powered astern from the rock and made a slow speed passage to a more sheltered anchorage off Middle Beach, LHI (FIG.1). The ship had extensive forward flooding and the Forward Engine Room was also flooded via a Stabilizer Shaft. The MEO (LIEUTENANT COMMANDER Ian GROOM RN) described the grounding and ship's staff actions at Reference 1.

FIG.1 HMS NOTTINGHAM AT LORD HOWE ISLAND

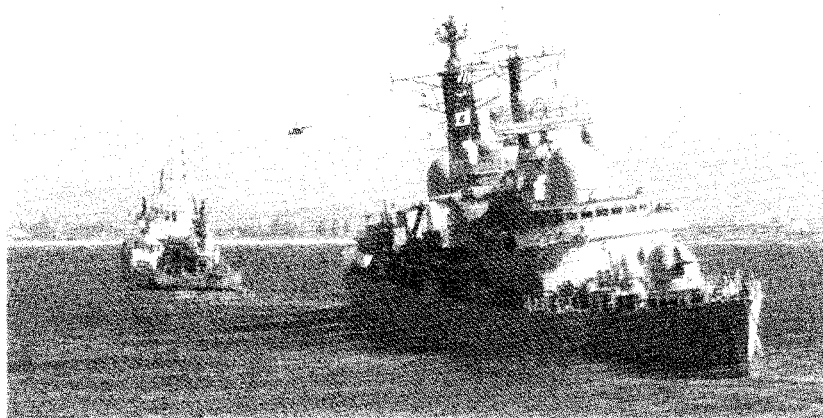
FIG.6 ENTERING NEWCASTLE NSW

The *Nottingham* towed as predicted, with no directional instability, with an average of 5.5 knots through the water. The quarterdeck was goffered on many occasions but the flight deck was dry, in abnormally calm conditions.

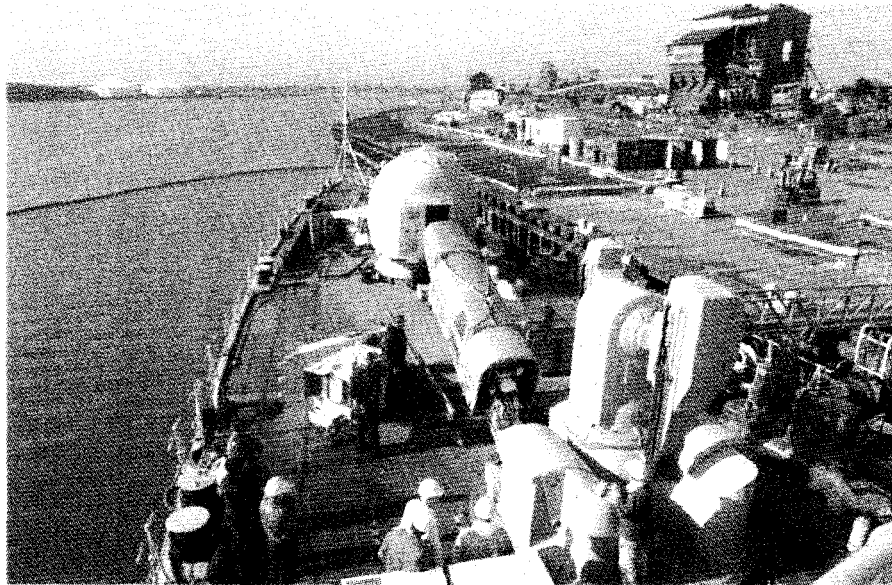
hull. Missiles were removed at an average rate of 5 per day and inspected (FIG.7).

FIG.7 SEA DART REMOVAL AND BERTH INFRASTRUCTURE

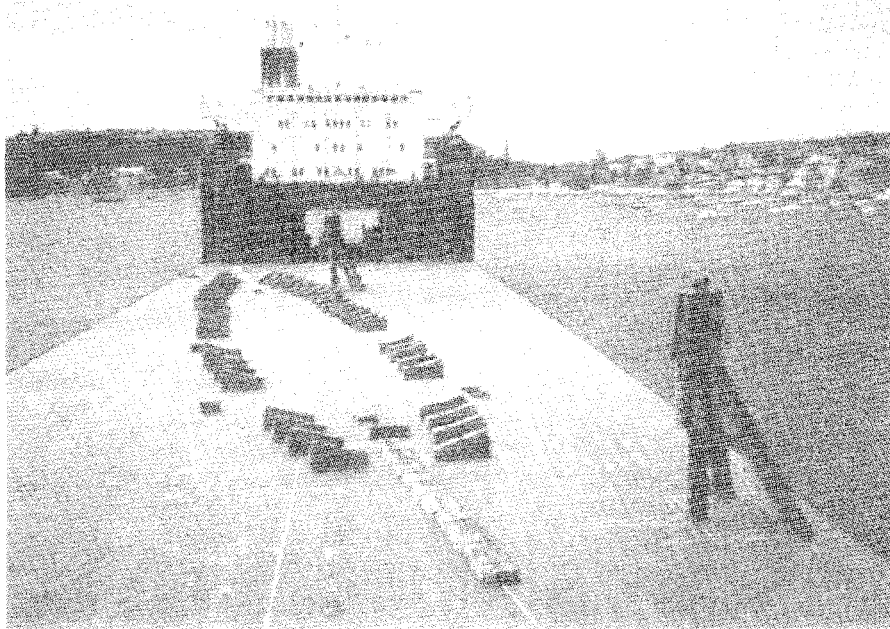
FIG.8 MV SWAN CRIBBING ARRANGEMENTS

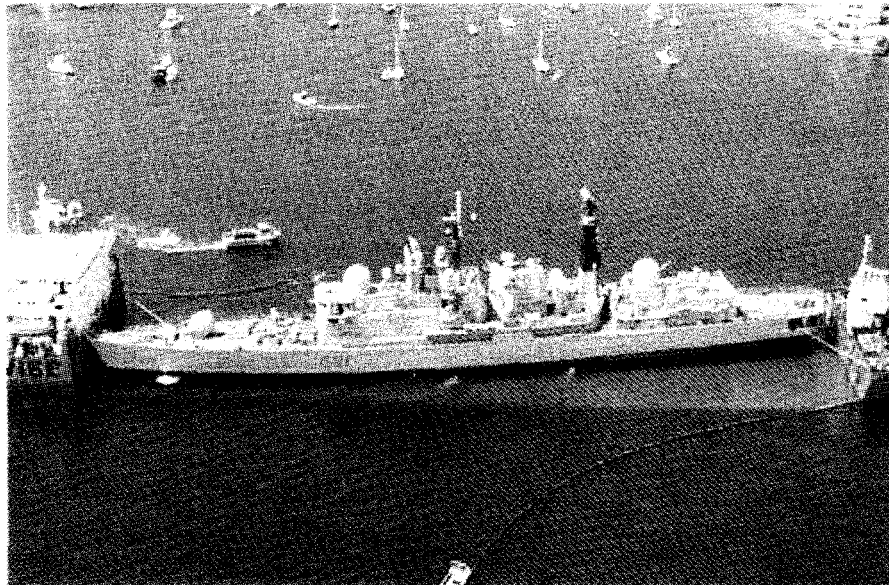
Nottingham was sued at 0930, and the bow of *Swan* was de-ballasted to allow the forward port corner of her cargo deck to emerge first. This sequence was critical to ensure satisfactory levels of stability and to have a controllable water-plane throughout the operation, requiring at one stage a 7 meter trim (FIGS 9 & 10).

FIG.9 - HEAVY LIFT OPERATIONS IN SYDNEY HARBOUR

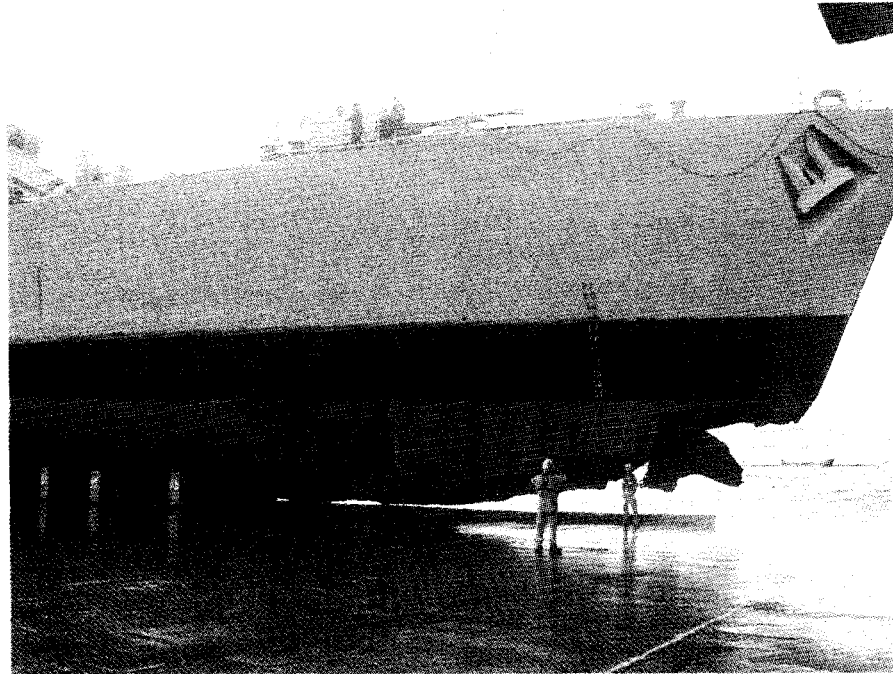
FIG.10 HMS NOTTINGHAM ON MV SWAN

The cargo deck was dry at about 1400 and the full extent of the underwater damage to *Nottingham* became apparent. The damage to the bow structure, whilst most spectacular was not that which caused the most concern (FIG.11).

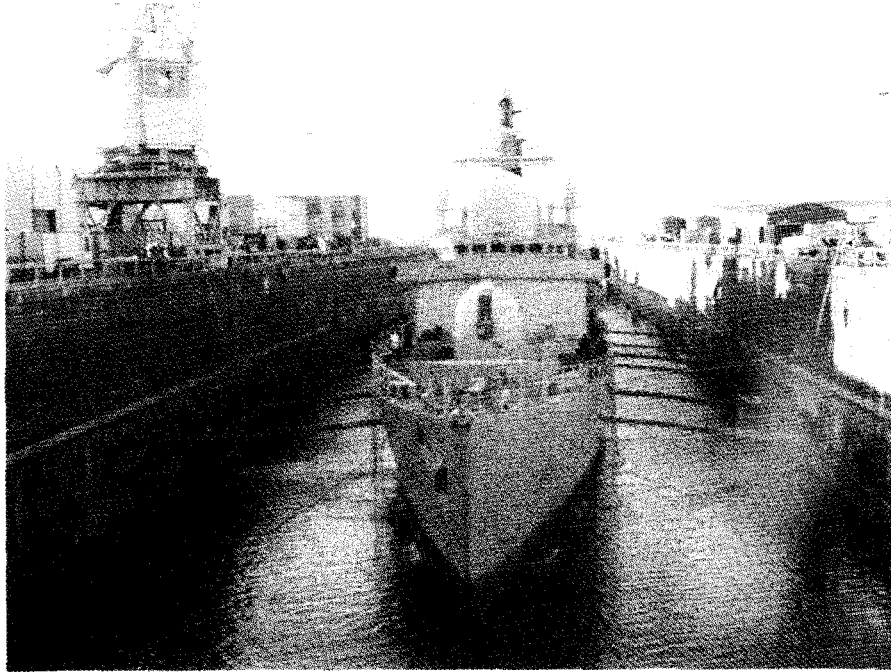
FIG.12 DRY DOCKING IN PORTSMOUTH

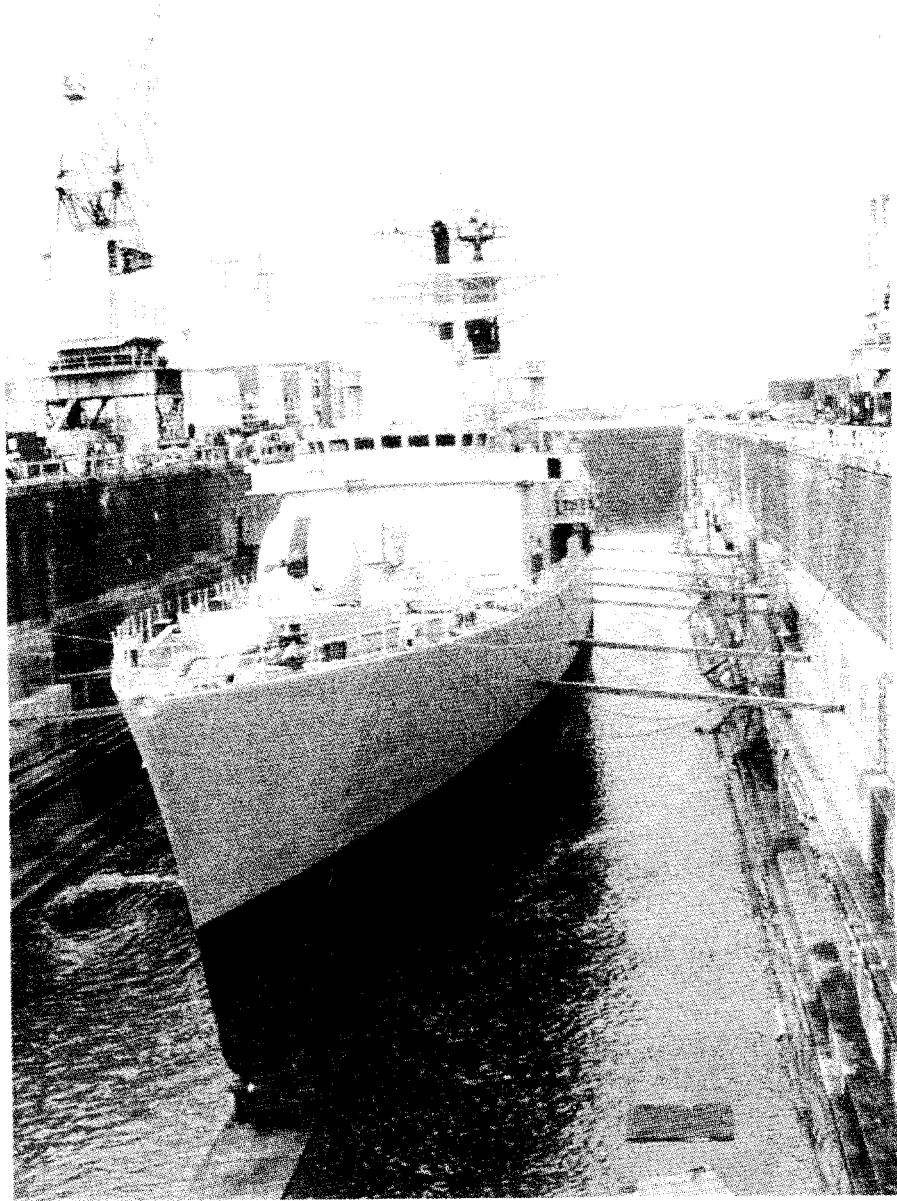
FIG.13 UNDOCKING ON 7 JULY 2003

The repair period began on 6 January 2003 and *Nottingham* was successfully undocked on the 7 July 2003 (FIG.13). The sluice gates were opened almost exactly a year to the hour after she hit Wolf Rock. Work is proceeding to the overall plan and the ship is expected to return to service in late 2004.
