THE FAILURE INVESTIGATION AND REPLACEMENT OF A LARGE MARINE GEAR

ABSTRACT

Following a routine inspection of HMS *Invincible's* main propulsion gearboxes, cracking was identified on the starboard main wheel teeth. This article presents a summary of the subsequent work, including: the palliative repair, inspection regime, risk reduction measures, failure investigation, the design and manufacture of replacement gears and the permanent repair.

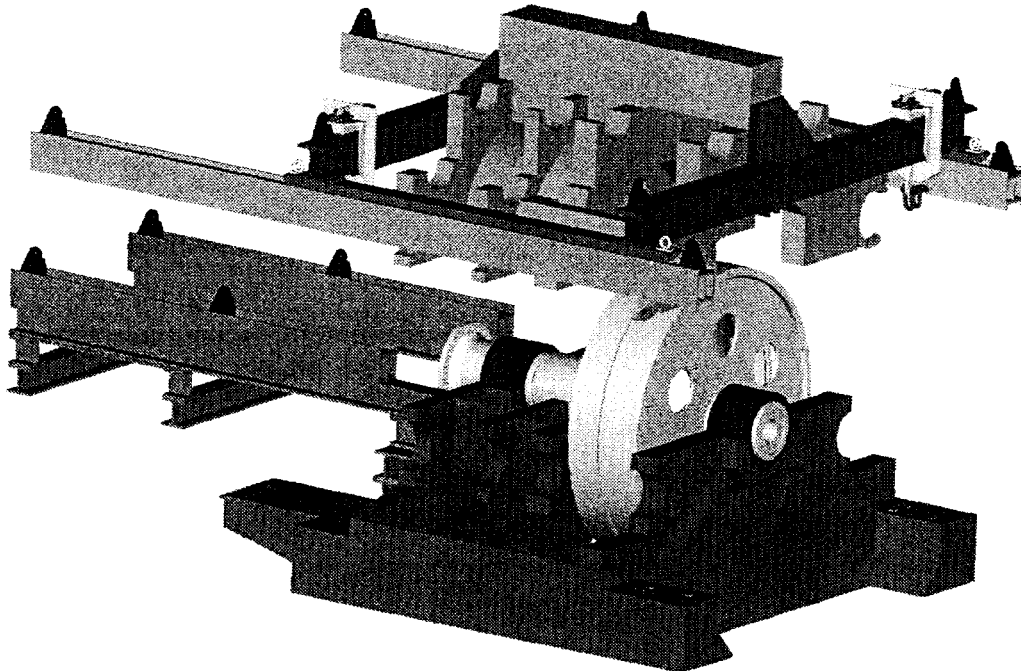
FIG.10 – 3D MODEL OF LIFTING ASSEMBLY

Without cutting through the compartments above, cranes could not be used to lift the 'A' frame or main gear wheel. The solution devised was based on a lifting assembly (FIG.10) consisting of beams lifted by four hydraulic jacks and a stack of cans to provide four columns for the lifting rails to sit on.

The four jacks would lift the beams and then cans would be placed between the seatings and the lifting rails and the assembly lowered onto the cans. Additional cans would be placed under the jacks and the process repeated until the lifting rails were at the correct height to allow the 'A' frame to be moved.

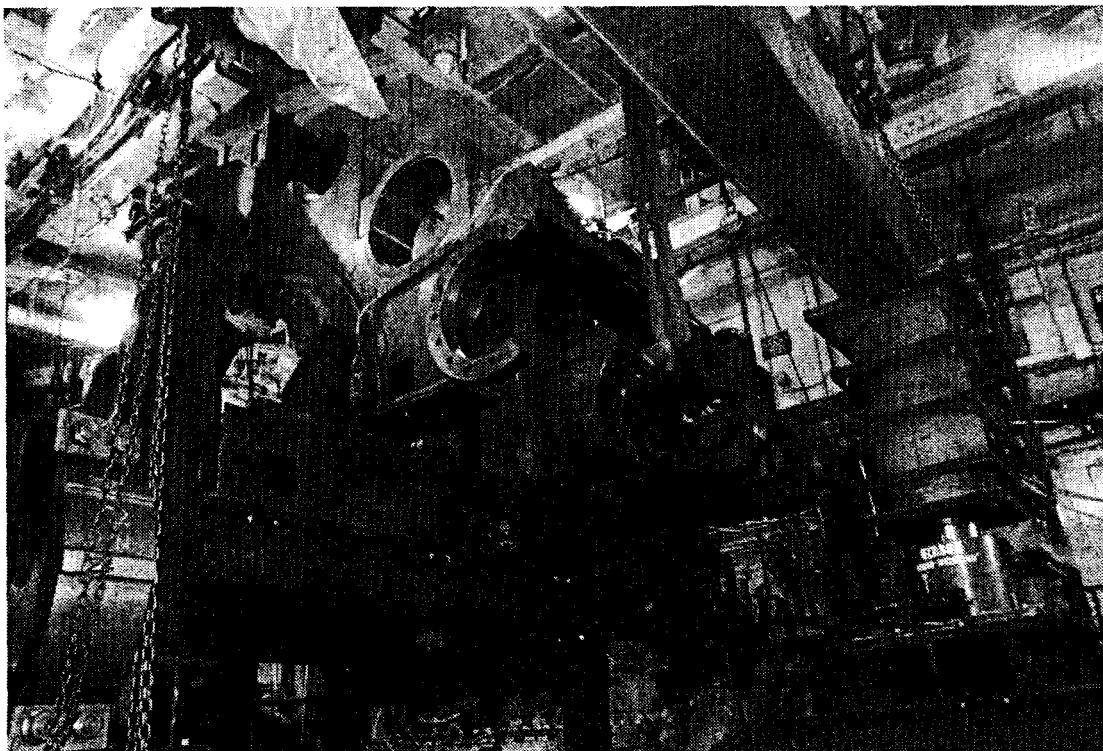
FIG.12 – LIFTING THE 'A' FRAME

- It is worth noting that the gearbox is inclined inline with the propeller shaft, which slopes by 2.2 degrees. As a result, the 'A' frame had to be lifted perpendicular to the shaft line to prevent it fouling the main wheel (Fig.12).

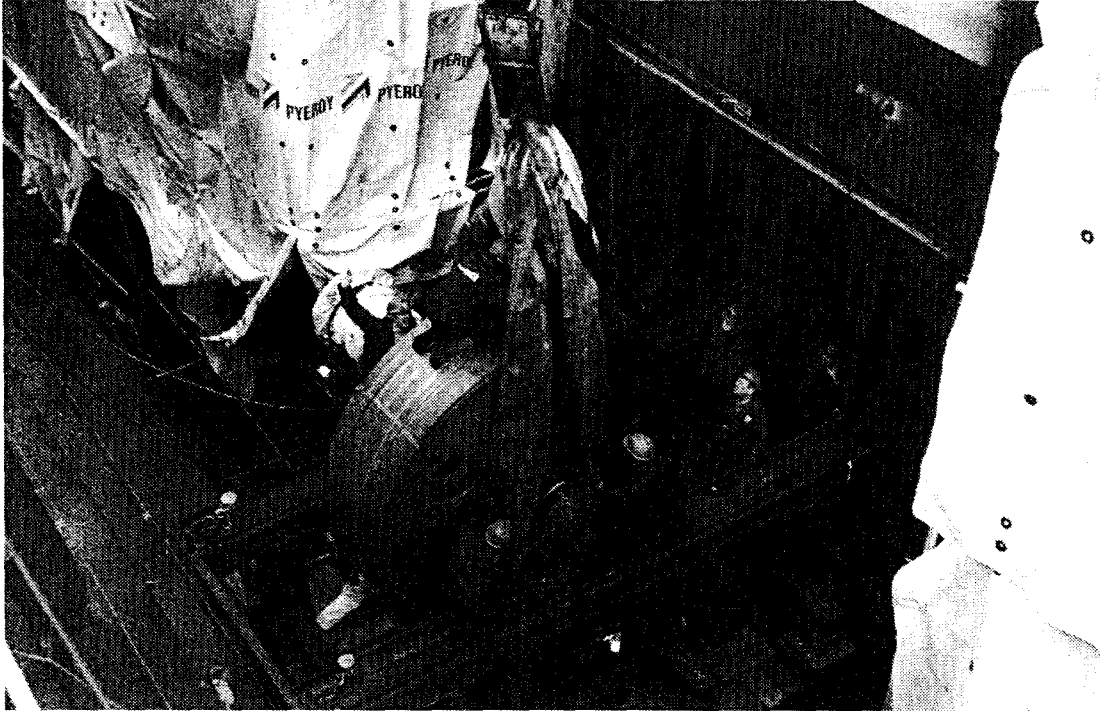
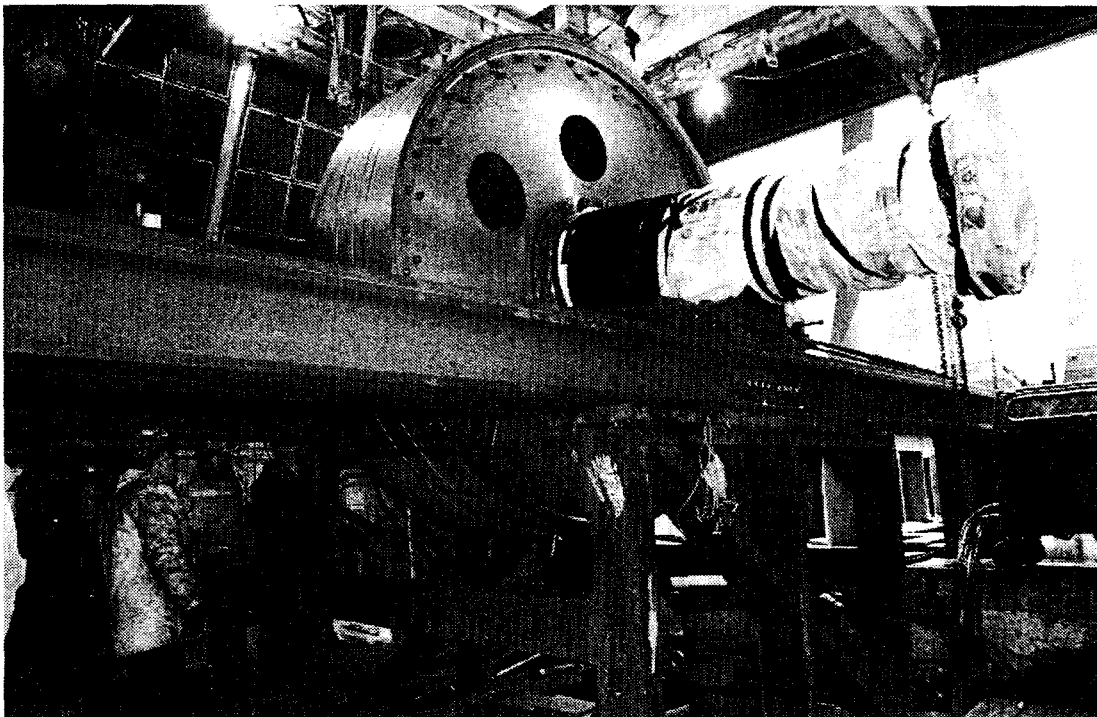
FIG.13 – FITTING THE NEW WHEEL

- The lifting assembly was then repositioned to lift the main wheel, which was then lowered onto a cradle and withdrawn from the ship sideways, before being craned onto the dockside (FIG.13).

The delivery of the replacement gears and the gearbox rebuild were on the critical path of the refit, so particular attention was given to monitoring the supply of replacement gears, to ensure that they were completed on time. The gears were provided on time and the rebuild proceeded, with the above steps being undertaken in reverse order. Particular attention was paid to:
