# HMS 'BRAZEN' SALVAGE AND REPAIR

I. M. PEACOCK, BSc, RCNC  
(*Naval Architect Warships Group 2, NSC, Bath*)

COMMANDER P.J. HORSTED, MENG, MSC, CENG, MIMARE, MINUCE,  
MIMECHE, RN  
(*formerly Marine Systems Manager Warships Group 2, NSC, Bath*)

## ABSTRACT

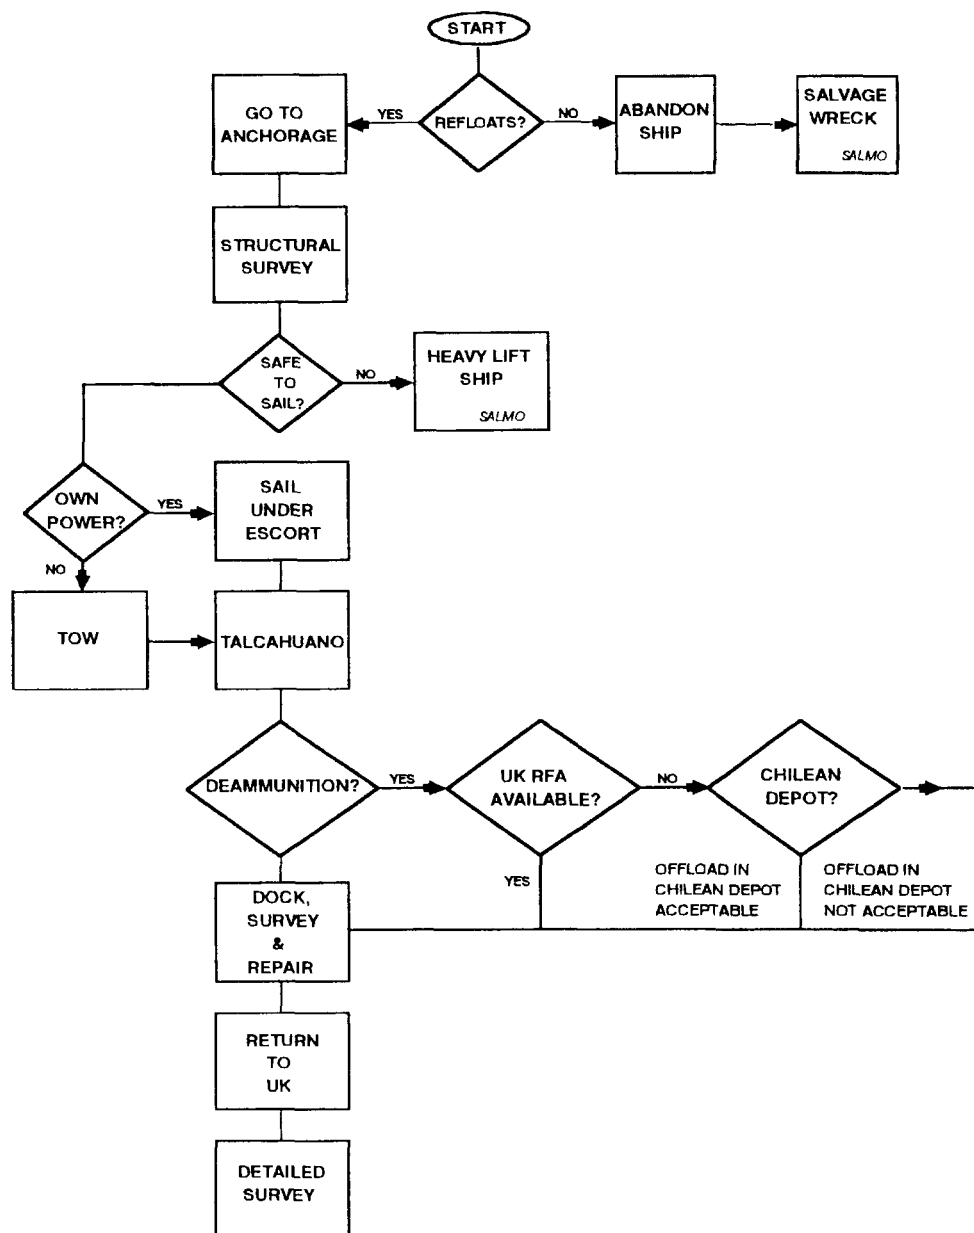
As an aid to planning and managing the task ahead the WPM's team produced a basic Decision Tree, (FIG.2). It was around this that 'all the immediate staff work was conducted and against which the priorities of headquarters activities were compared for the next few days.

Having confirmed with SFOMO at Northwood that there were no casualties and that the ship was, for the time being at least, stable the immediate consideration was would she refloat or not? If not, what were the consequences? FIG.2 shows that the inevitable result of not refloating was the abandonment of the vessel leading to a wreck salvage operation. Underlying this scenario were considerations of the implications of the embarked ammunition and the potential environmental impact of the fuel and other substances carried which were subject to the Control of Substances Hazardous to Health (COSHH) Regulations. Flag Officer Surface Flotilla (FOSF) Portsmouth quickly provided a 'substances' list and also an estimate of the environmental

FIG. 2—BASIC DECISION TREE
