SPEY SM1A MODULAR REPAIR EXPERIENCE

LIEUTENANT-COMMANDER M. R. J. MALTBY, BSC, RN
(*Sea Systems Controllerate, Bath*)

ABSTRACT

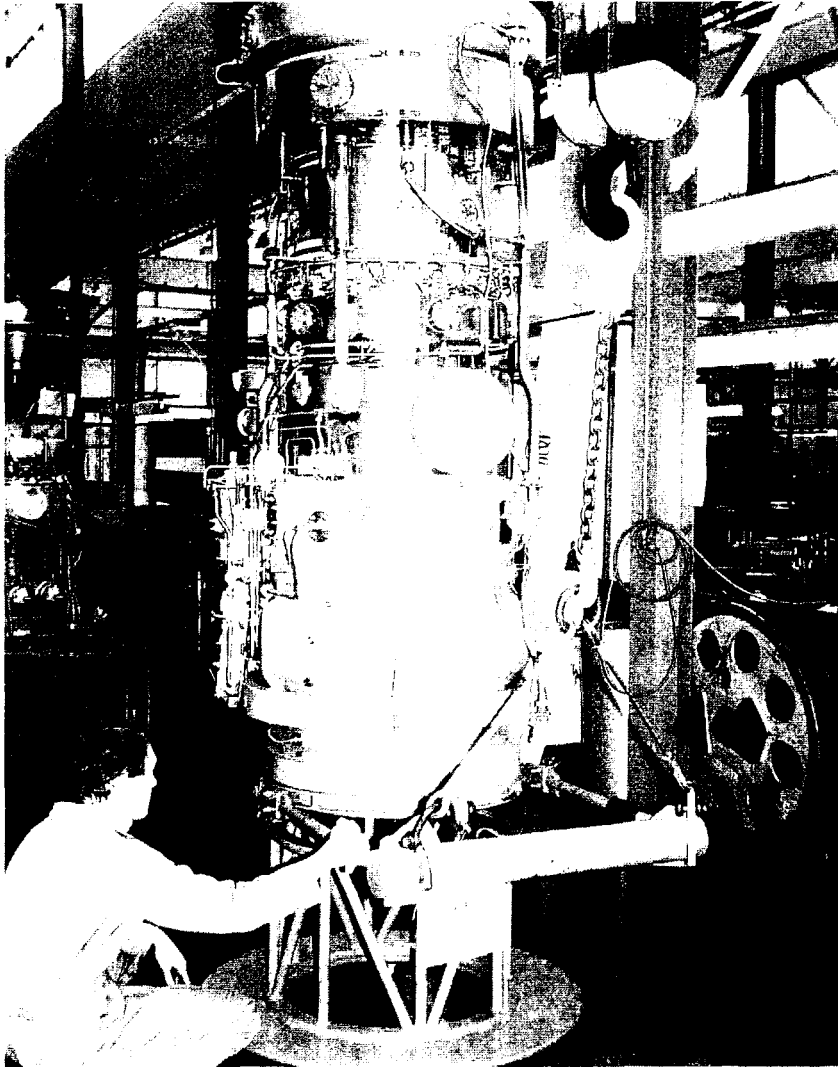
FIG. 3—SM1A GTCU IN POSITION FOR MAINTENANCE ASSEMBLY EXCHANGE

The exchange of MACUs is carried out with the GTCU mounted vertically in the 'nose down' position, as seen in FIG. 3, and the MACUs are lifted away from the 'tail' of the engine, either singly or in groups, to give access to the defective MACU(s) which are to be replaced. Two examples of MAX are shown in FIGS. 4 and 5, but of course it is possible to change more than one MACU at a time should a defect require it.
