SM1A MARINE GAS TURBINE EVALUATION AT PYESTOCK

ABSTRACT

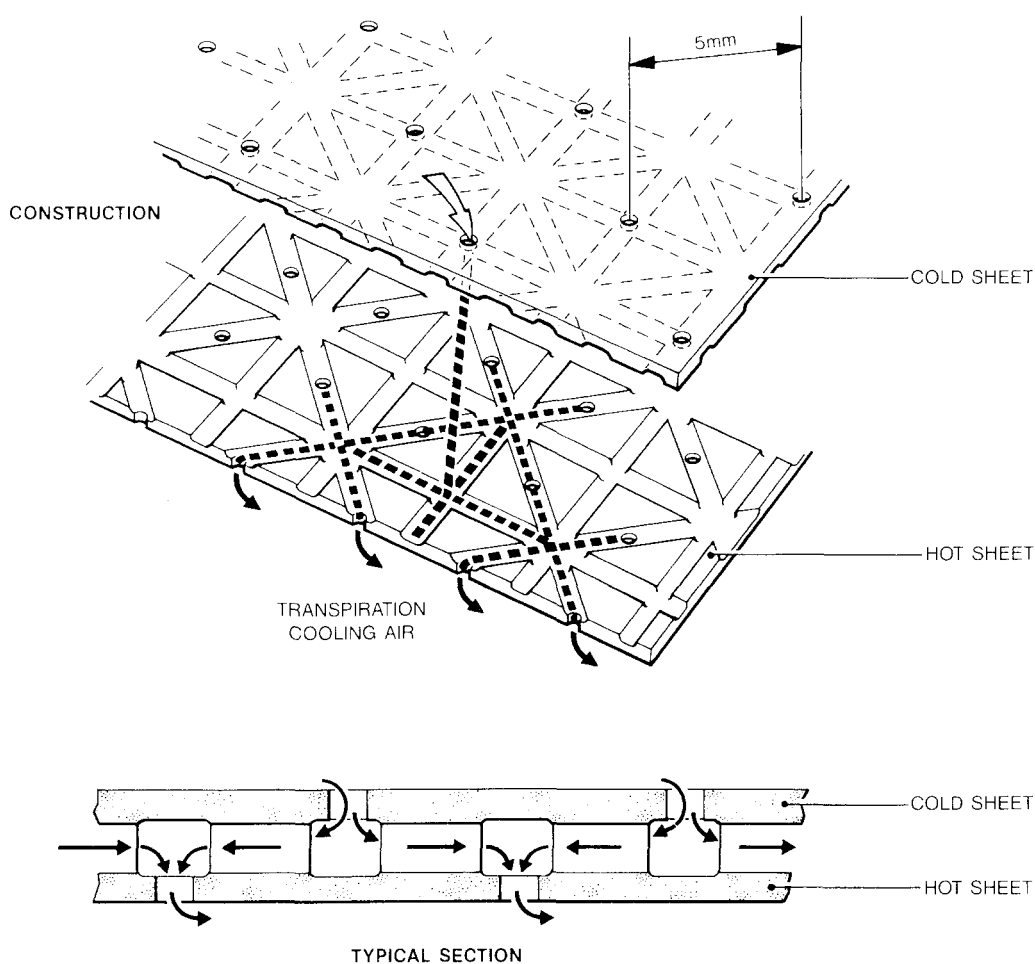
FIG. 3—NIMONIC 86 TRANSPLY SHEET MATERIAL

For the purpose of this trial, the GTCU was supplied with combustors made from Nimonic 86 Transply material (FIG. 3). These were a set of nine new IRAB combustors together with one IRAB combustor (fitted in position 3) that had already been used for cyclic testing with salt water in the airflow. The GTCU was then run to a predetermined schedule for 200 hours before the combustors were removed for examination and detailed

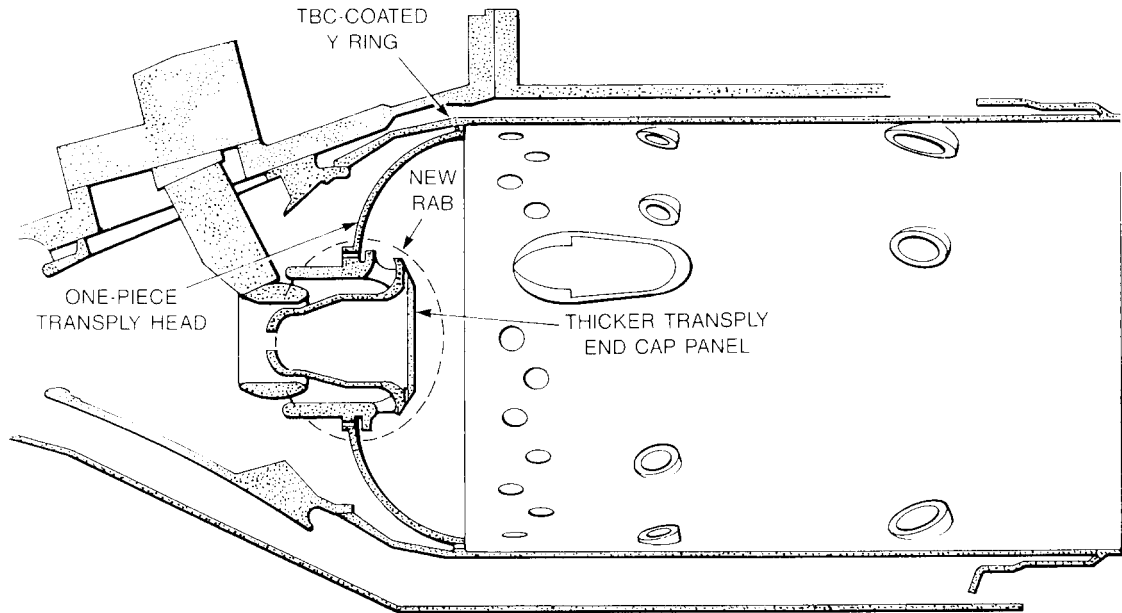
FIG. 7—ENHANCED REFLEX AIRSPRAY BURNER (ERAB)

Once 1000 hours had been achieved, the combustors were again removed from the GTCU and subjected to detailed inspection and examination. Considerable carburization and sulphidation had taken place in the combustors and the characteristic 'green rot' corrosion was plainly visible in all the combustors, the cooling ring in No. 3 combustor having been particularly severely attacked. At this point the opportunity was taken to examine the NGV1s in some detail and they were found to be in a comparatively good condition. On completion of the examination, a design review meeting took place at Rolls-Royce, Ansty, resulting in a proposal to enhance some of the IRAB combustors into Enhanced RAB (ERAB) combustors (FIG. 7).

The final outcome of the design review exercise was that combustors 1, 2, 7 & 10 were fully enhanced, combustors 3, 4, 5 & 8 RAB bodies and end caps were replaced with existing design Nimonic 86 Transply material, and combustors 6 & 9 were left unaltered as a datum (TABLE I).
