# H.M.S. 'GUERNSEY'— GROUNDING AND SALVAGE

## E. C. M. HAIG, C.ENG., F.R.I.N.A., R.C.N.C. (Sea Systems Controllerate)

#### ABSTRACT

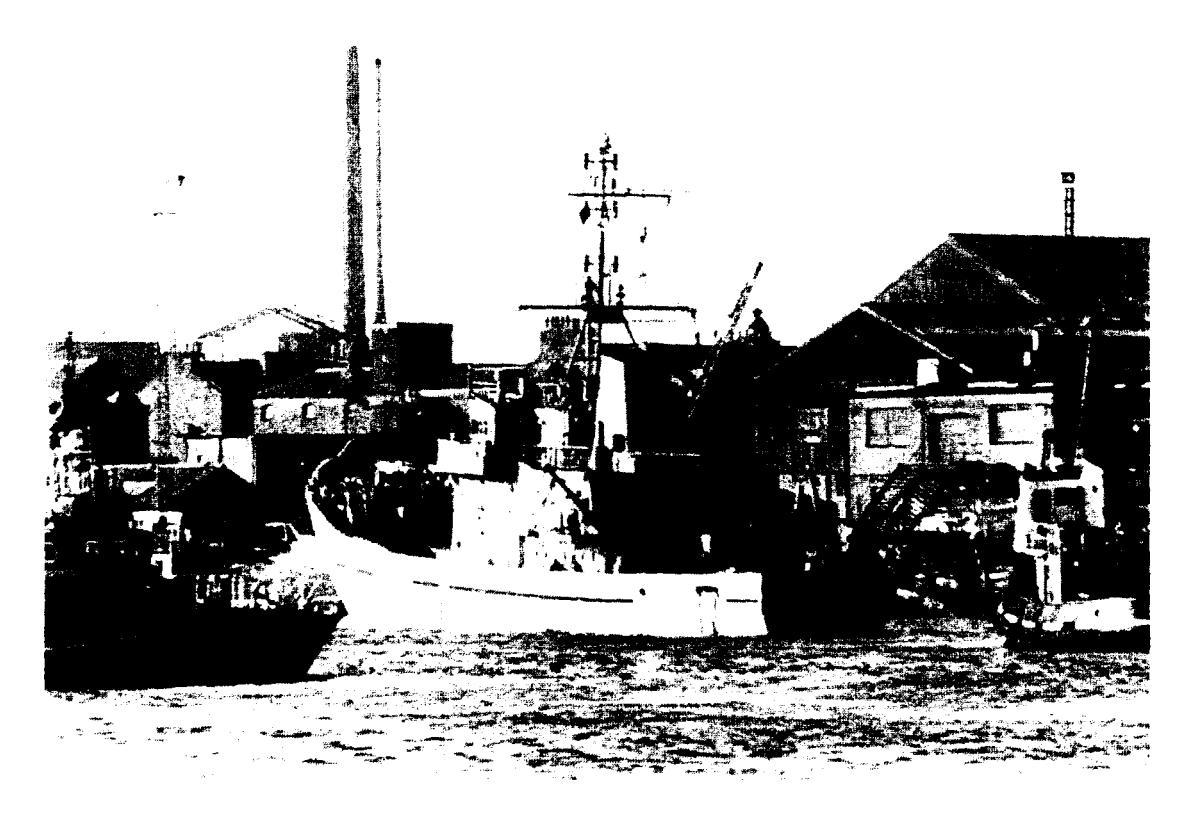
estimated stability characteristics are shown in FIG. 11. The reserves of buoyancy before the loss of the ship would have been inevitable were about 700 tonnes. *Guernsey* was towed into Aberdeen harbour (FIG. 12) and she was secured alongside Hall Russell's yard where she was built ten years before.

FIG. 12-H.M.S. 'GUERNSEY' BEING TOWED INTO ABERDEEN HARBOUR
