A CRACKING TALE OF CPP BLADES AND HOW THEIR HEALTH IS BEING RESTORED

LIEUTENANT-COMMANDER N. D. LATHAM, M.Sc., R.N.
(formerly of Sea Systems Controllerate)

LIEUTENANT-COMMANDER D. N. BRITTEN, B.Sc.(ENG.), C.ENG.,
M.I.MECH.E., R.N.
(Sea Systems Controllerate)

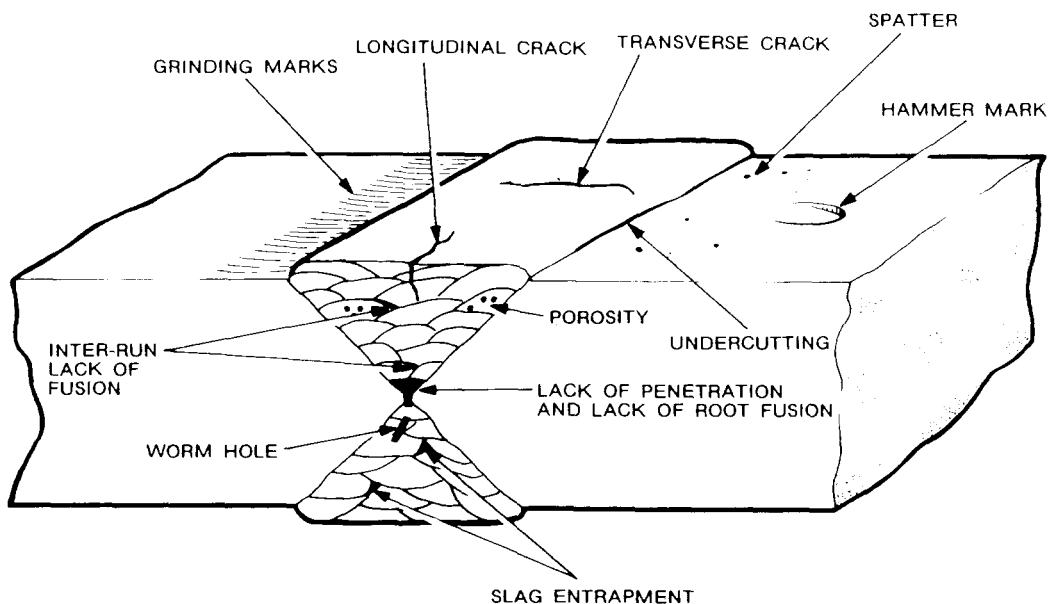
FIG. 8—TYPICAL WELDING DEFECTS

Radiography (FIG. 7) can be used for the detection of defects that give rise to voids in the specimen and others which are in line with the radiation beam. Examples of these (FIG. 8) are:

- (a) Lack of weld fusion arising from poor penetration, lack of inter-run or side wall fusion (though the latter would be probably require angle beam radiography).
- (b) Cracks (though tight cracks at large angles to the beam may not be seen).
- (c) Slag—non-metallic or metallic inclusions (e.g. tungsten or copper, dependent on the weld process).
- (d) Porosity, wormholes (or piping), elongated cavities.
