MARINE GAS TURBINES

A REVIEW

COMMANDER J. M. KINGSLAND, C.ENG., M.I.MECH.E., R.N.
(*Ship Department*)

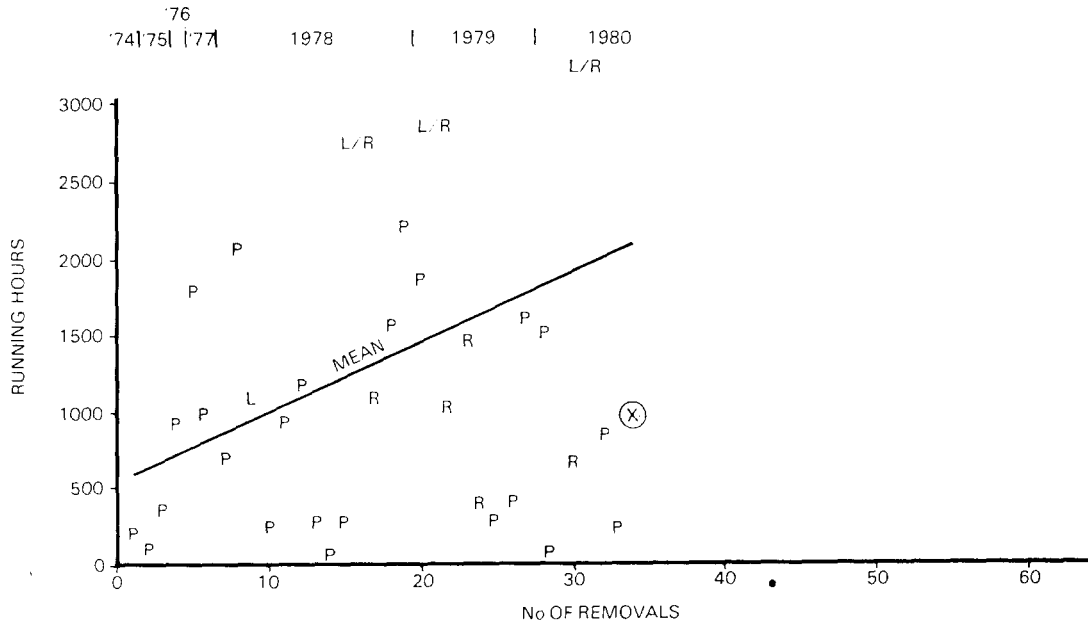
FIG. 1—OLYMPUS TM3B ENGINE REMOVALS

Key: L = Life expired
 R = Ship refit
 P = Premature
 X = Average of 56 engines in service—973 hours

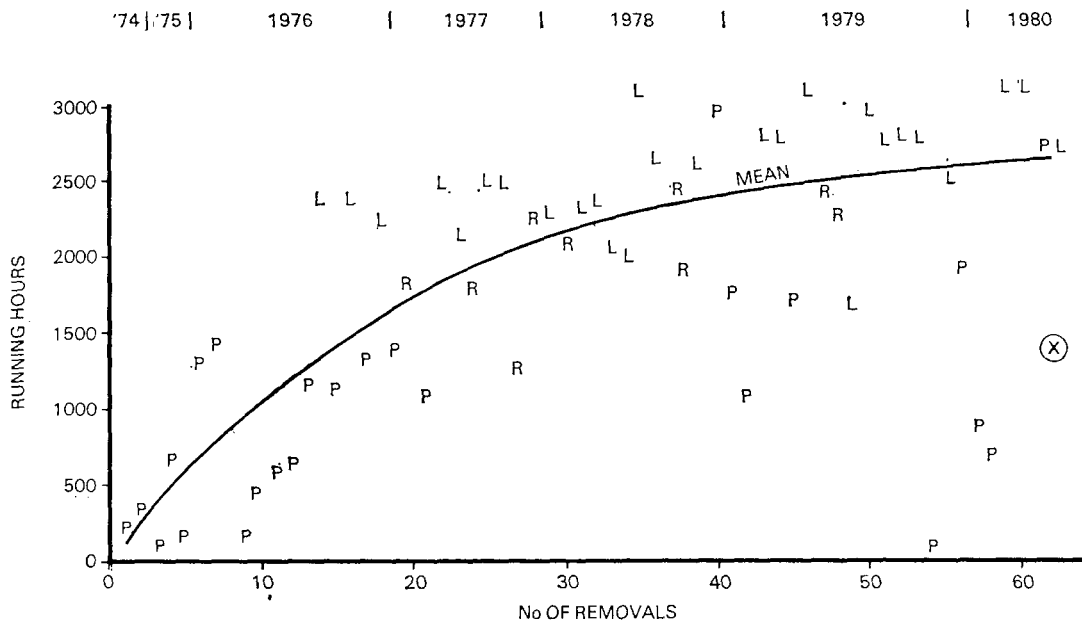
FIG. 2—TYNE RM1A ENGINE REMOVALS

Key: L = Life expired
 R = Ship refit
 P = Premature
 X = Average of 34 engines in service—1390 hours
