MARINE GEARBOX EXPLOSIONS

A REVIEW

COMMANDER M. D. COOPER, C.ENG., F.I.MAR.E., R.N.
(*Ship Department*)

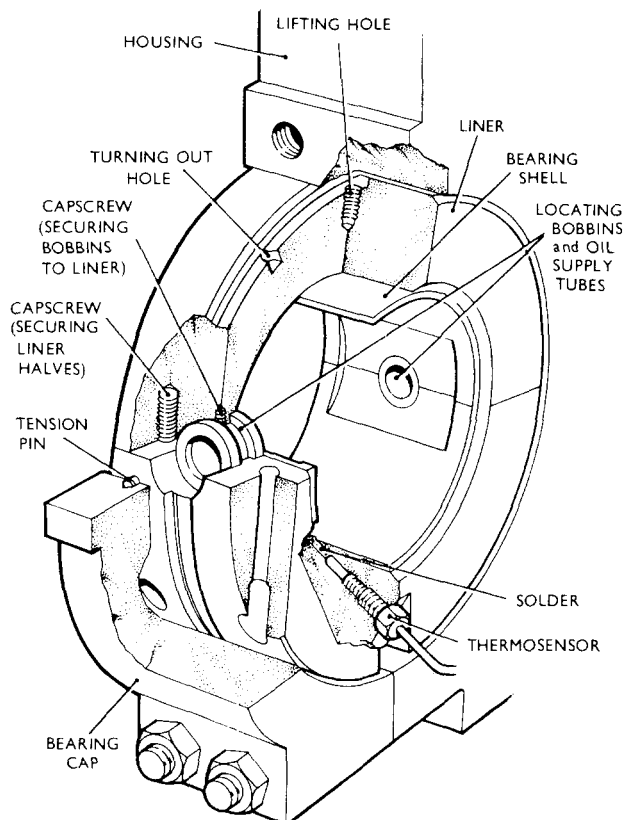
FIG. 4—TYPICAL THERMOSENSOR ARRANGEMENT

the investigations that poor contact on the back of the bearing has given rise to spurious low-temperature readings. In the 1970s, the R.N. changed, in some installations, to resistance thermometers with the thermosensor spring loaded to the back of the bearing shell by an arrangement that was dimensionally interchangeable with that of earlier ships. FIG. 4 illustrates a typical thermosensor arrangement.

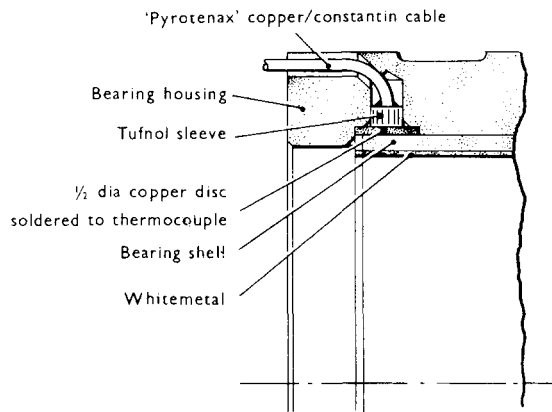
FIG. 5—TYPICAL THERMOCOUPLE ARRANGEMENT

Note: Good contact of disc face with back of thin shell bearing is essential

a disc (FIG. 5) rather than the more usual pencil-like probe, and this is press fitted into the housing so that there is a positive contact with the back of the bearing shell. In journal bearings of the thick-wall conventional type, the bearing sleeve is drilled to within, or close to, the whitemental and a thermocouple having a small junction is secured by a screwed arrangement.

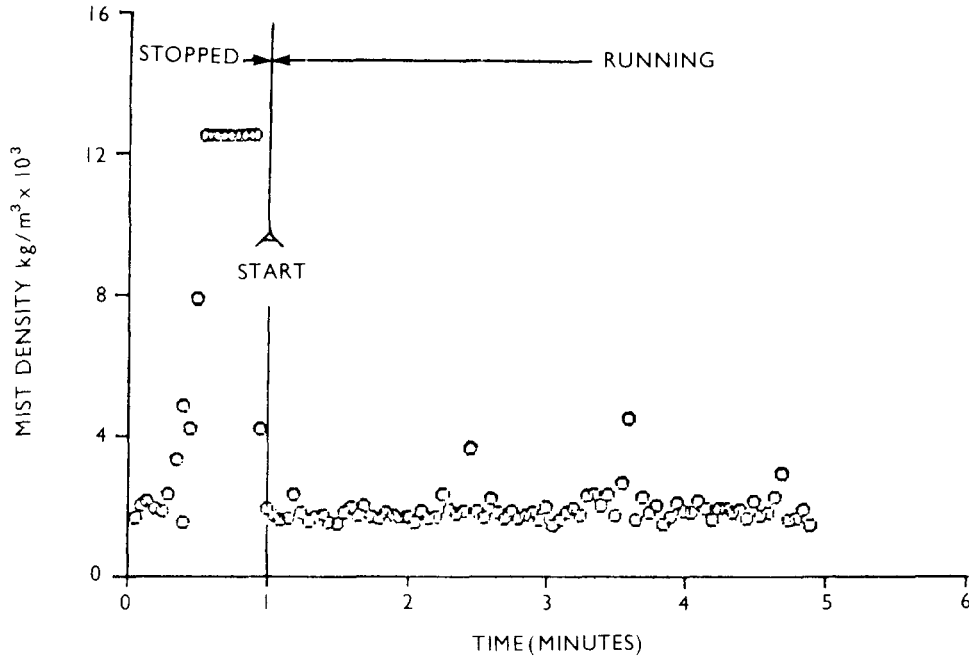
FIG. 8—VARIATION OF MIST DENSITY: STOPPED/RUNNING

values obtained without mist injection. FIG. 8 shows a mist detector read-out during this period indicating the rapid change in reading within seconds of the gearbox being started. This effect was repeatable and was undoubtedly due to the large oil drops impacting the mist droplets and so removing them from suspension.
