# BOILER DAMAGE EVALUATION

## FOLLOWING AN INCIPIENT STEAM-STEEL REACTION

L. P. JUDSON, L.I.M.

*(R.N.Z.N. Naval Research Laboratory Metallurgy Section)*

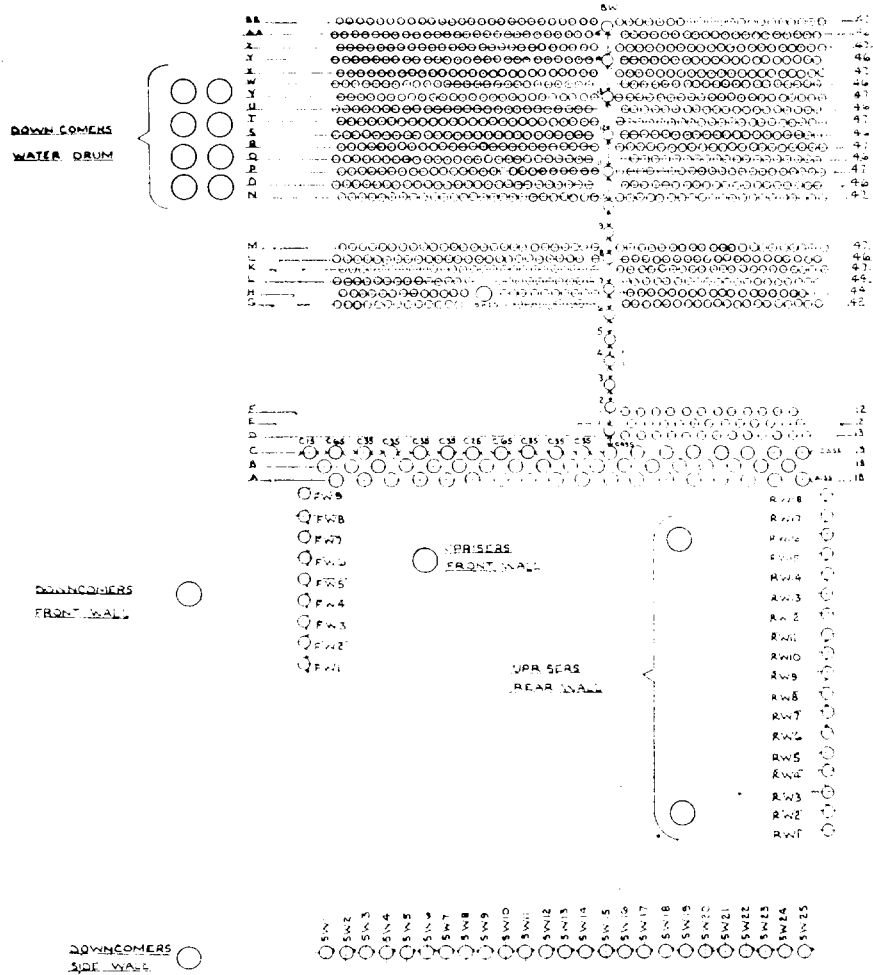
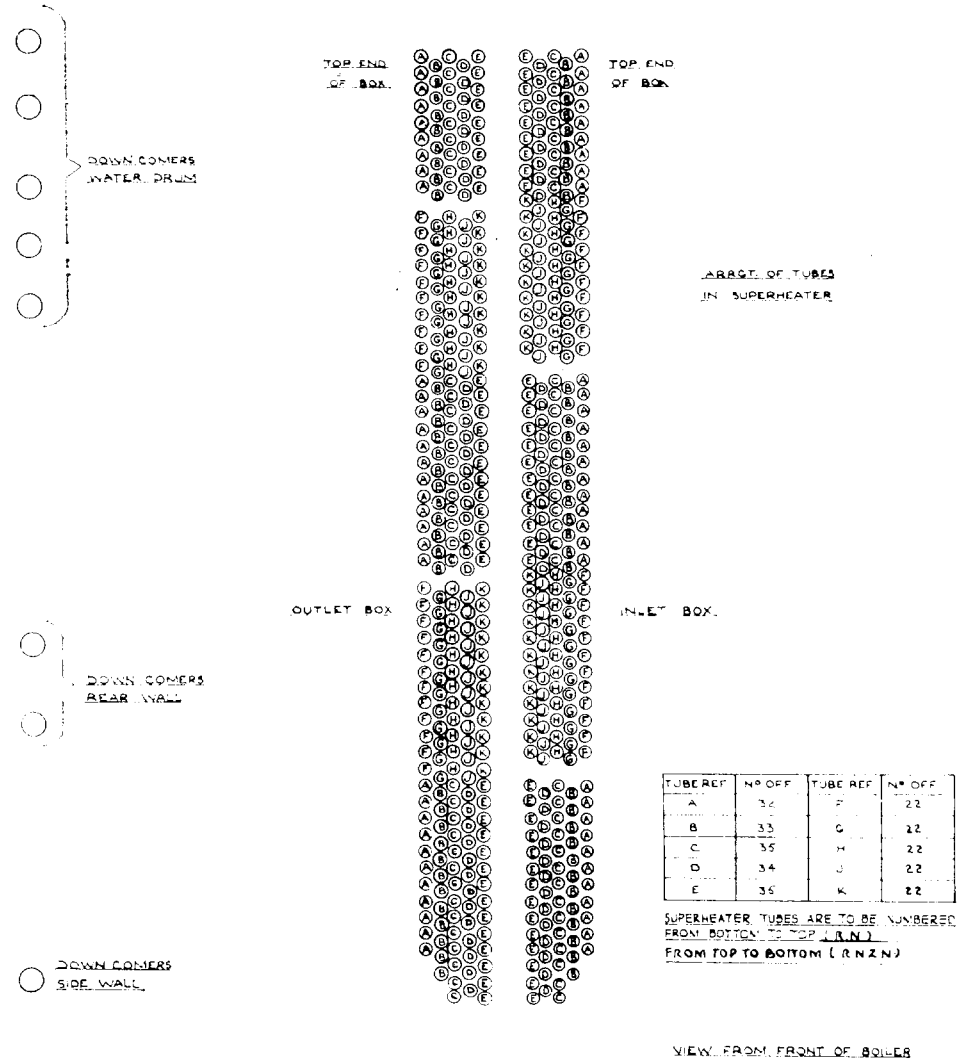
FIG. 1—TUBE IDENTIFICATION CHART FOR Y.100 STARBOARD BOILER

Frequent reference is made to the tube numbering system in accordance with BR 3100, Tube Identification Chart. FIG. 1 was reproduced from BR 3100, with minor modifications to facilitate the disposition of tubes in a Y. 100 boiler
