SOME NAVAL ENGINEERING CALAMITIES

COMMANDER A. J. H. GOODWIN, O.B.E., R.N., M.I.MAR.E.

The following paper was presented to the Scottish Branch of the Institute of Marine Engineers in October, 1964, by the author who is now the Senior Manager of the Yarrow-Admiralty Research Department. The naval calamities he describes are those with which he has had personal contact and the events are associated with the ship in which he was serving at the time. Many of these events provide some lessons in engineering both on the technical side and even more on the administrative side.

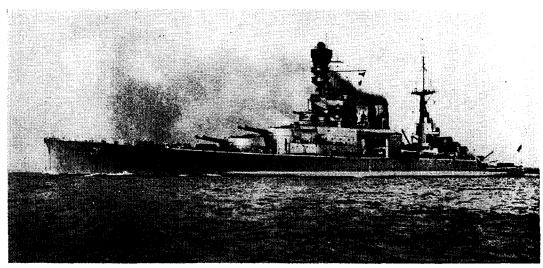
FIG. 2—H.M.S. RENOWN

My next ship was H.M.S. *Renown*, and here a real calamity arose which might have led to very serious consequences. This was a very big fire in the boiler rooms, and it occurred in 1927 when we had on board the Duke and Duchess of York who subsequently became King George VI and Queen Elizabeth. They had been visiting Australia and New Zealand and the ship was on her way home about half way between Australia and Africa, in fact, in about the position that S.S. *Trevessa* had sunk a year or so previously when an epic voyage was made by her boats to reach Mauritius.

The upper part of FIG. 3 shows the arrangement of the machinery compartments at that time, and the lower part the re-arrangement when she was reengined, completing in 1939. It will be seen that at the time there were 42 boilers arranged in six boiler rooms—A containing three, B seven and C, D, E. and F eight each. The fire broke out early in the afternoon watch in D boiler room, while the ship was steaming on C and D boilers. It subsequently transpired that the cause of the fire was oil fuel that was being transferred from forward to one of the double bottom tanks in D boiler room. The filling arrangements were a stand pipe with an open-ended funnel and a filling valve above. The stoker who was tending this valve made the cardinal error of sounding the wrong tank, so that as he could see no rise of level, he kept opening the valve wider and wider until the tank and its stand pipe were completely full and the oil overflowed, some of it striking the hot boiler front and catching fire.

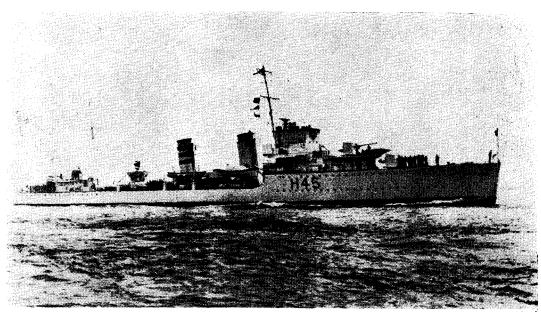
FIG. 4-H.M.S. ACHERON

The technical troubles that she had were leaking joints, which was largely a matter of workmanship with the higher pressure, some material problems due to the higher temperature, and principally H.P. turbine vibration above a certain speed. The first two had been cured before I joined her, but the turbine vibration was the reason that she had been consigned to the Local Flotilla at Portsmouth, the duties of which were such that high speed was desirable but not essential.

Several attempts had been made to diagnose the turbine trouble but whenever Admiralty officers were present to observe the trials she refused to produce the symptoms and the Admiralty officers were able to go away saying whatever the trouble was it seems to be cured now, and you can cancel the limitation on your speed. Of course, after their departure the very first attempt to use high speed produced vibration and the limit was put on again. The very intermittance of the trouble gave the clue that it was a transient temperature condition that was causing the vibration, and very soon we were in a position to inform the Admiralty that if they would send observers, we could guarantee to make the turbine vibrate. How nice it is to be in a position of being encouraged to make a thing go wrong rather than being blamed if it doesn't go right. Basically, it was a loosening of the H.P. turbine shrunk joint which occurred for a time after opening the first of the two by-pass valves. When heat had soaked through thoroughly the joint tightened up and the ship could then run at full power quite happily. During the time when the joint was loose there was a tendency to touch in the labyrinth gland, overheat locally, and distort sufficiently to prolong the vibration.

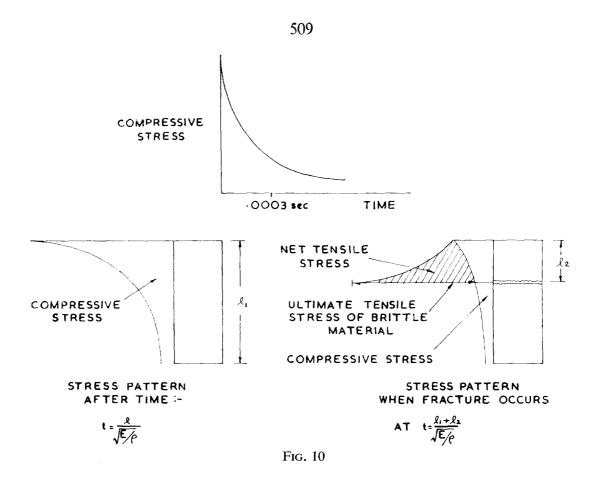
being reflected at a free surface as a tensile wave. FIG 10 shows what occurs if the stress wave is very short-lived, and it can be seen that a material such as cast iron with good resistance to compressive stress can withstand the upward passage of the stress wave but due to its weakness against tensile stress will fail in tension at a point when the tensile wave is returning and the net tensile stress exceeds the ultimate tensile stress of the material. The fact that it was obvious that a majority of failures of machinery items occurred during deceleration rather than acceleration lent some mistaken credence to this reflected stress-wave theory of the fractures that occurred in ships. For a little time even the great Professor Haigh, who was naturally called in by the Admiralty as a consultant, was misled in this matter; however, he was thereafter invaluable in assisting us to reconcile stress wave theory with what was actually occurring. In a pressure pulse the particle velocity is directly proportional to the stress intensity and in a compressive stress this velocity is in the direction in which the stress wave is proceeding, while in a tensile stress wave the velocity is in the opposite direction to that in which the stress wave is proceeding.

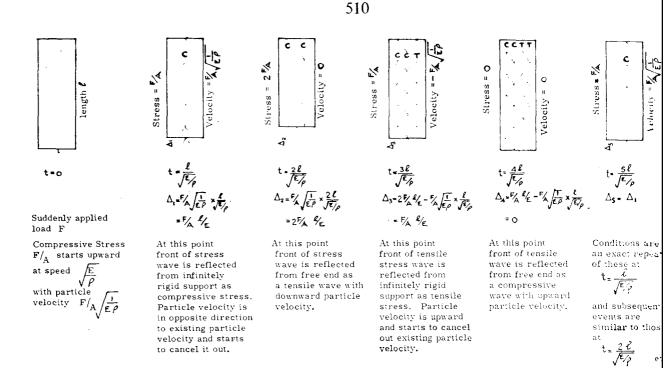
The effect of a suddenly applied continuous force on a fixed body and on a free body is shown in FIGS. 11 and 12. The pattern of the stress wave in the ship's frames as a result of non-contact underwater explosion is not as simple as that assumed for these examples, but consists of two parts:

This shows that taking stress wave into account the overall effect is the same as that obtained from conventional theory with a suddenly applied force, namely, an oscillation about a mean compression of stress $\frac{1}{E}$ x length.

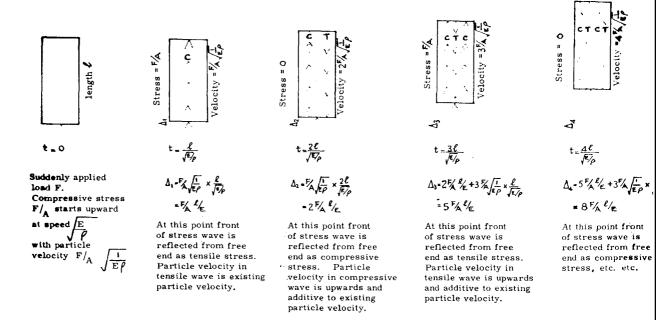
FIG. 11

This shows that taking stress wave into account, the overall effect is the same as that obtained by conventional theory with a suddenly applied constant force, namely, the whole body moves off with an acceleration of $F_A = \int \frac{1}{E\rho} per \frac{\ell}{\sqrt{E\rho}}$ seconds or an acceleration of $F_A = \int \frac{1}{E\rho} \frac{1}{E\rho}$

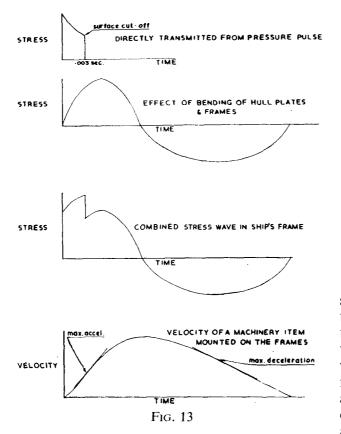
- (a) That directly transmitted from the pressure pulse in the water, which is sharpfronted with an exponential fall-off for about 0.003 secs. when 'surface cut-off', reduces it to zero.
- (b) That caused by resistance to the inward bending of the hull plates between the ships' frames due to the action of the pressure pulse in the water on these plates, and modified by the frames' own resistance to bending.

The resultant stress wave is as shown in FIG. 13. It can be seen that this remains positive for a time which is long compared with the time taken by a stress wave to traverse a machinery item, i.e., half a millisecond for an eight-foot height, and the concept of bodily acceleration and deceleration is justified.
