THE DEVELOPMENT OF NYLON PROPELLERS

LIEUTENANT-COMMANDER E. W. WARD, R.N.

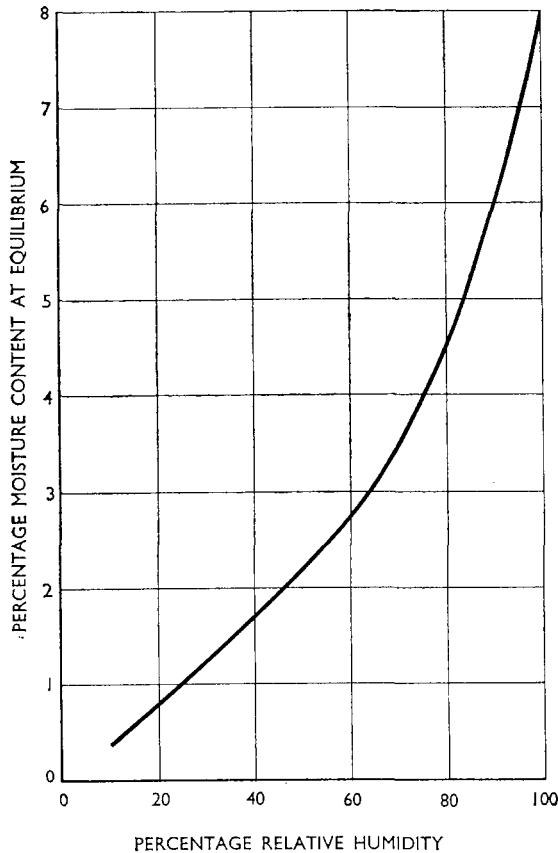
FIG. 1 shows the variation of maximum moisture content with humidity at room temperature and for complete immersion, the Equilibrium Water Content (percentage) at room temperature is quoted as being 9.0—10.0 per cent.

FIG. 1—VARIATION OF MAXIMUM MOISTURE CONTENT WITH HUMIDITY AT ROOM TEMPERATURE.

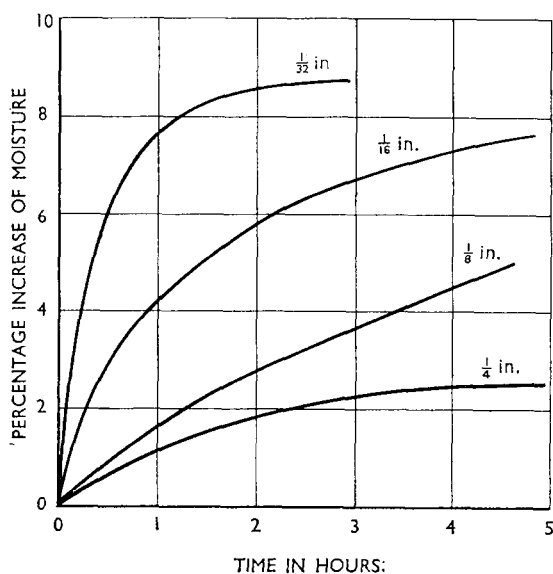
If nylon was left to absorb moisture from the atmosphere by its natural process, it would take a long time before the equilibrium state was reached, but this process can be accelerated by immersion in boiling water. FIG. 2 shows the rate of moisture pick-up for various thicknesses of Nylon 66 material under the latter conditions.

FIG. 2—RATE OF MOISTURE PICK-UP FOR NYLON 66 IN BOILING WATER

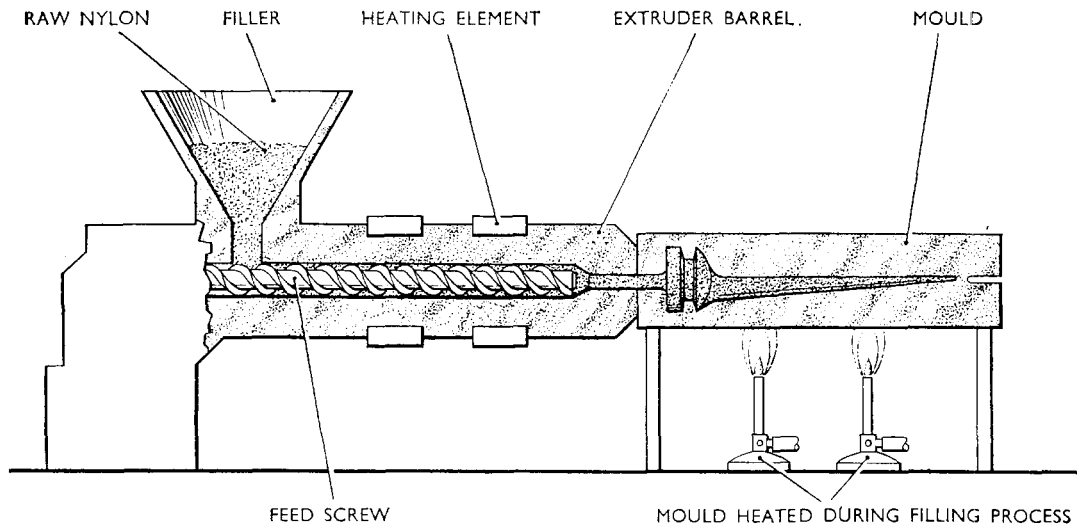
Another disadvantage which has been apparent with this method of manufacture is that, because of the high pressures involved, the moulds have to be of very rigid construction, and have to be accurately finished such that the two halves when clamped together form a perfectly tight joint. To date, it has been found that this can only really be satisfactorily achieved by the use of stainless steel moulds which consequently are very expensive. FIG. 3 shows in diagrammatic form, a typical extrusion moulding machine.

FIG. 3.—DIAGRAM OF EXTRUSION MACHINE

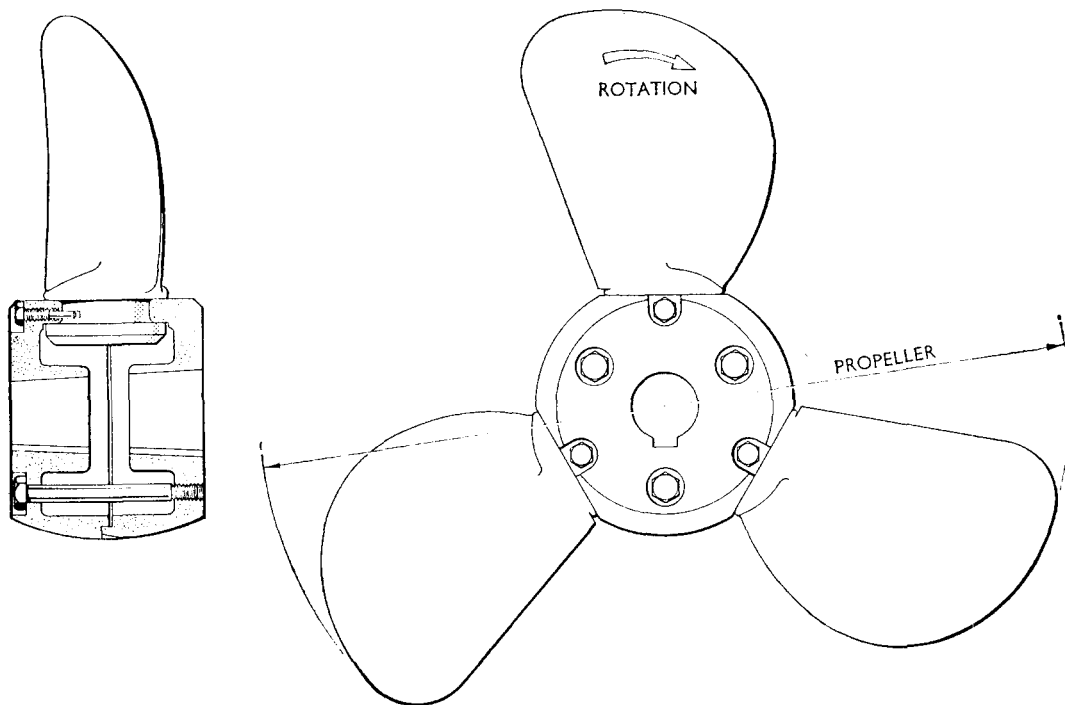
The method of locating the blades and clamping the halves of the bronze boss together are shown in FIG. 4.

FIG. 4.—DRAWING OF BOSS ARRANGEMENT
