CORRUGATED-MONEL EVAPORATOR BASKETS

MANUFACTURE, INSPECTION AND REPAIR

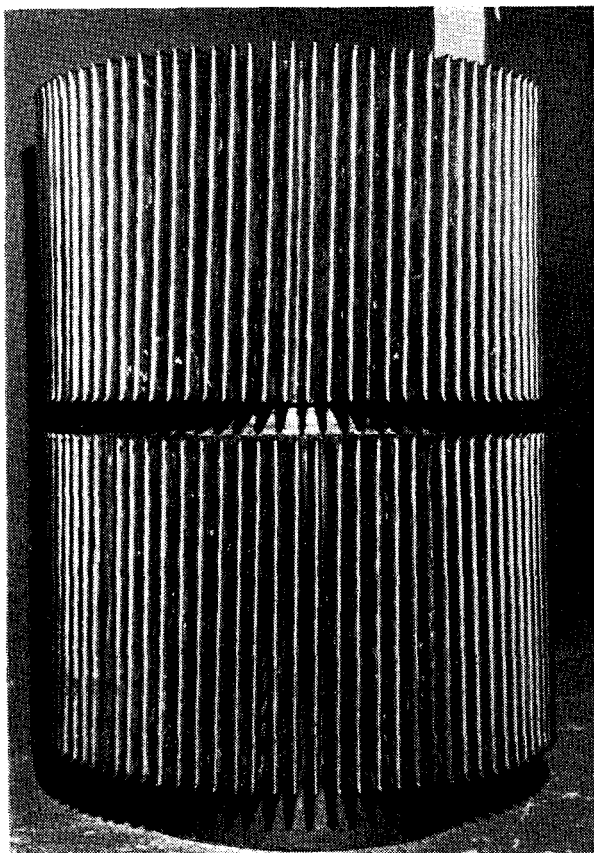
FIG. 1—MONEL EVAPORATOR BASKET

The first problem was to discover a suitable non-destructive testing technique which would reveal the reason for the failed seams and perhaps show the failures. Due to various factors it was decided that radiography was the only practical method inspection for these units. Although as can be seen from FIG. 1 the geometry of the basket was not ideal for this type of examination.

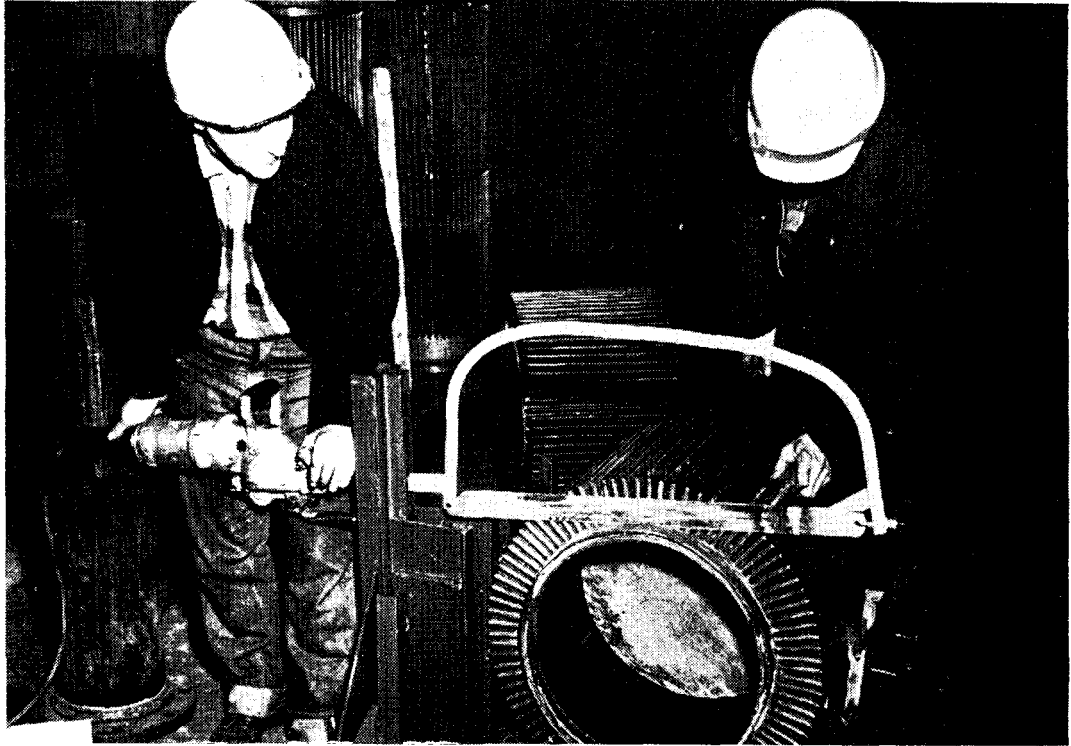
FIG. 2—POWER SAW AND HOLDING JIG

A number of methods to section the baskets were tried, the most successful being a unit designed and built by the Boiler Shop under Manager Constructive Departments' direction. Using this tool a basket can be clamped in any position and with a portable power hack saw modified for the job, the baskets could be sectioned with the minimum loss of time due to dressing of damaged edges. (See FIG. 2.)
