## H.M.S. ORION AT CRETE, MAY, 1941

COMMANDER (E) H. FARQUHAR ATKINS, D.S.O., D.S.C., R.N.

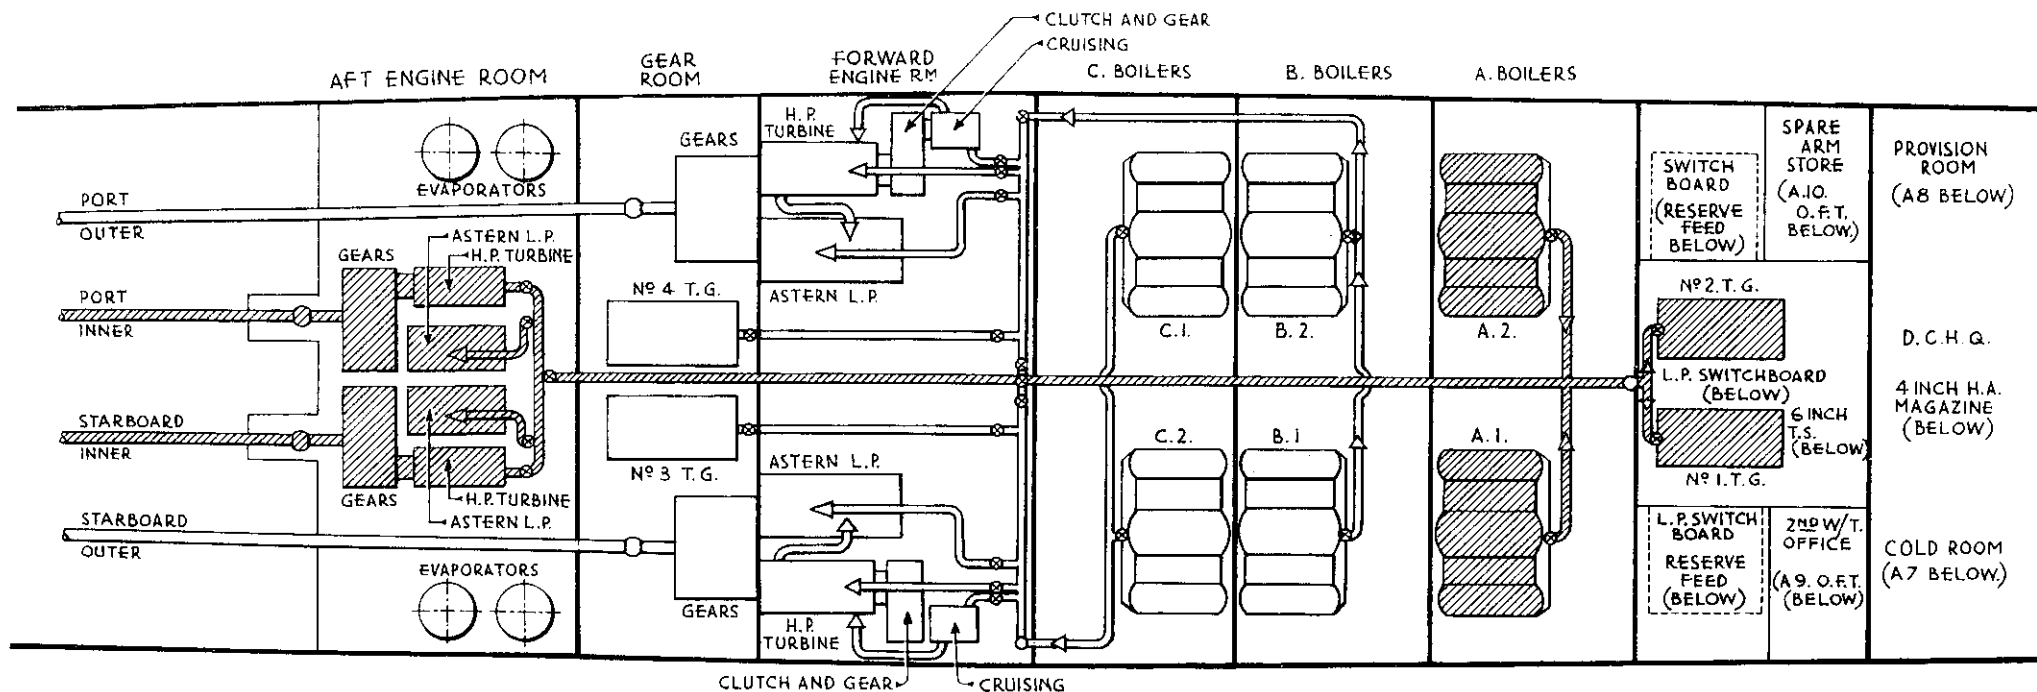
FIG. 1. H.M.S. "ORION" — MACHINERY ARRANGEMENT

As there was a complete set of gauges for all three units at the control position in the forward engine-room and both main steam cross-connection valves were there it was easy to cross-connect and isolate main steam as necessary, levelling off the main feed tanks when required. The machinery lay-out is shown in Fig. 1. The three units were of equal power, the two inner shafts together giving the same power as one of the outers.
