NOTES FROM SEA

The following are extracts from letters received by the Engineer-in-Chief's Department from Engineer Officers of seagoing ships, together with comments, where appropriate.

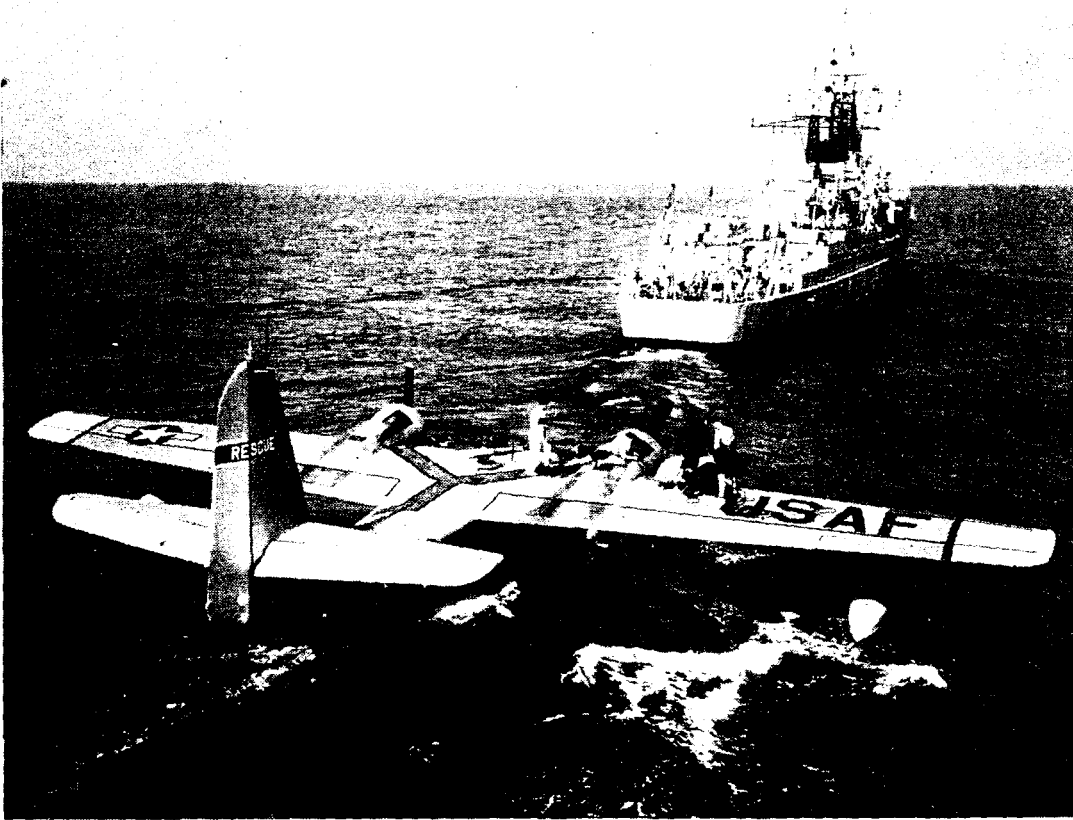
H.M.S. 'WAKEFUL' TOWING AN AMERICAN AMPHIBIAN RESCUE AIRCRAFT, ABANDONED AFTER A RESCUE ATTEMPT AT SEA
