BOAT BUILDING ON THE CHINDWIN RIVER.

The following article was contributed by an engineer officer who was attached to the British Army in Burma for some months in 1945 to assist in the building of the vessels described. In addition to installing the machinery, the author played no mean part in assisting in the actual construction of these interesting craft.

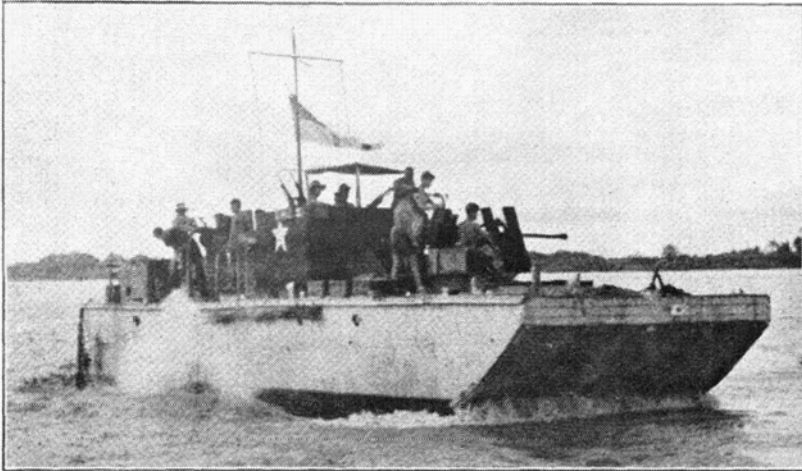
"PAMELA," ONE OF THE CHINDWIN RIVER GUNBOATS

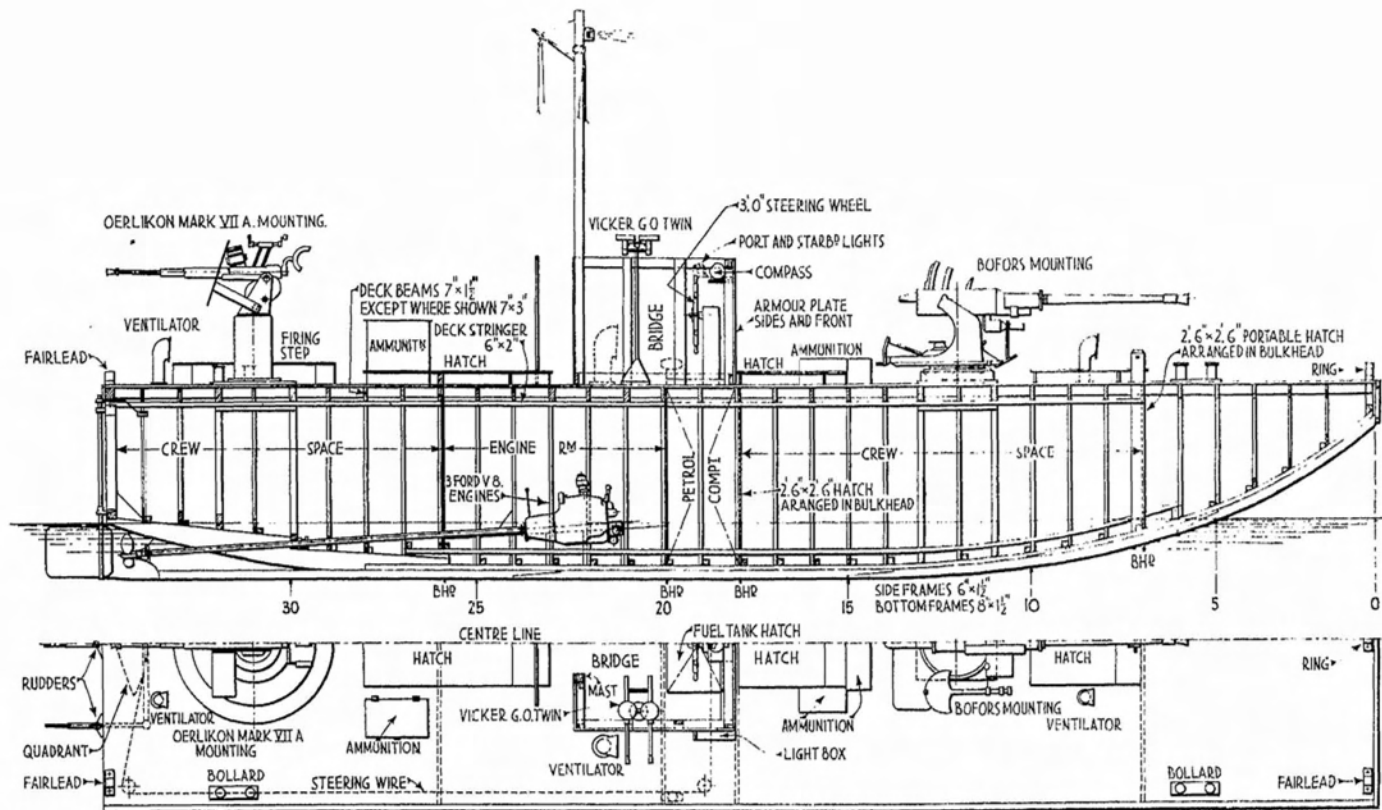
HALF PLAN

GENERAL ARRANGEMENT OF A CHINDWIN RIVER GUNBOAT

As may be seen from the general arrangement drawing on page 43, the boats were flat bottomed with a rectangular midship section, the bottom being swept up in a curve forward to meet the deck line. This was designed for beaching during landing operations. The boats were capable of carrying a platoon of troops in landing operations, and could carry about ten tons of stores when the draught limitation did not apply. In the dry season the maximum permissible draught is often 2 ft. 6 in., or slightly less, so it was of great importance that the boats should not alter their trim to any great extent. With this in view, the petrol tanks were arranged amidships. The

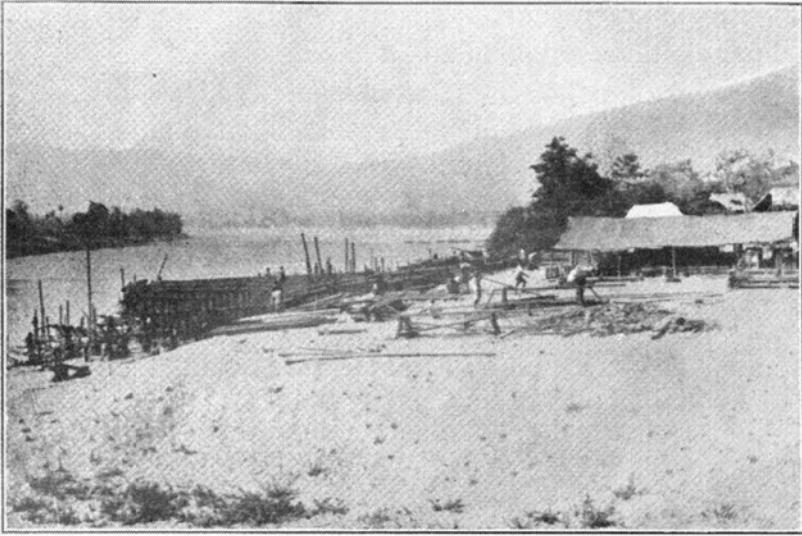
GENERAL VIEW OF THE BUILDING SITE

The building site was near Kalewa (see map on page 42) on the sandy banks of the Chindwin river, and was some 30 ft. above the water level in the dry season. This naturally caused some launching difficulties. The officers of the company detailed for the building were all either architects or house builders before the war. Under extremely trying circumstances the company made a very good attempt at boat building, their previous experience in this class of work being confined to a large number of dumb lighters. Given seasonably good materials and proper fastenings, the quality of workmanship would have been good.

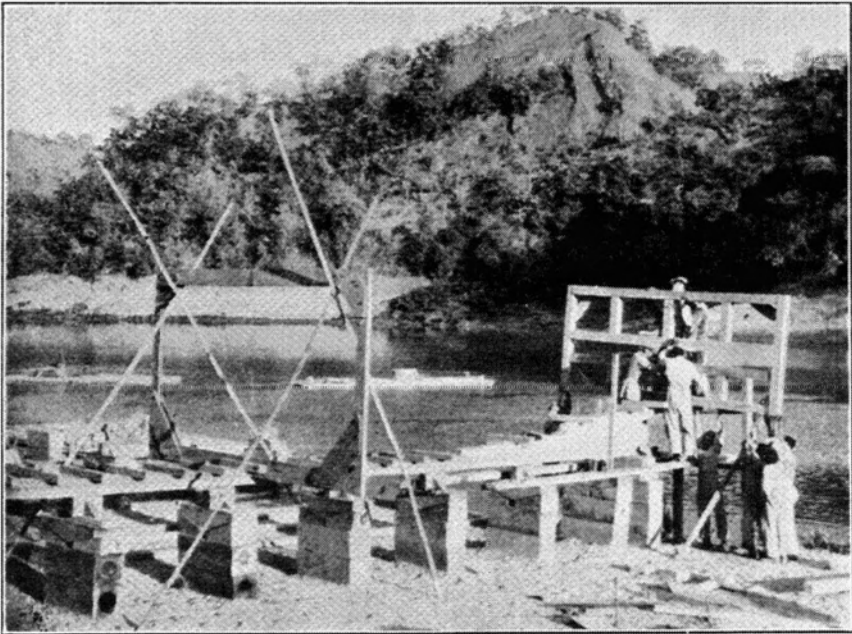
FITTING THE TRANSOM TO NO. 1 BOAT

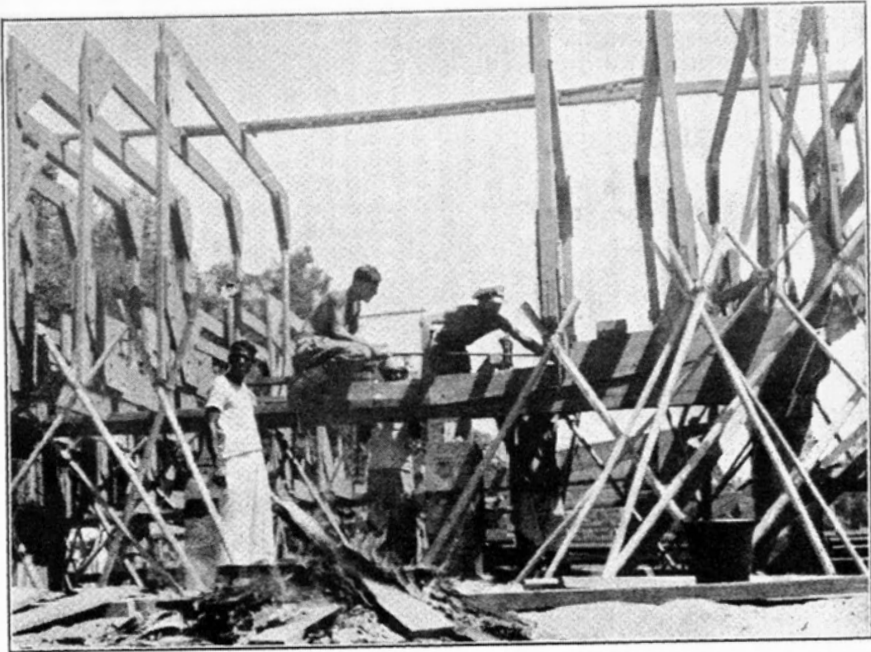
OFFICERS BORING THE STERN TUBE

Indians had the faintest idea of what it was all about (see illustration on page 46). It was burning hot on the river bank and bonfires and red hot poker made conditions far from comfortable. The final boring of the shaft logs was left until the rest of the boat was in a more advanced stage.

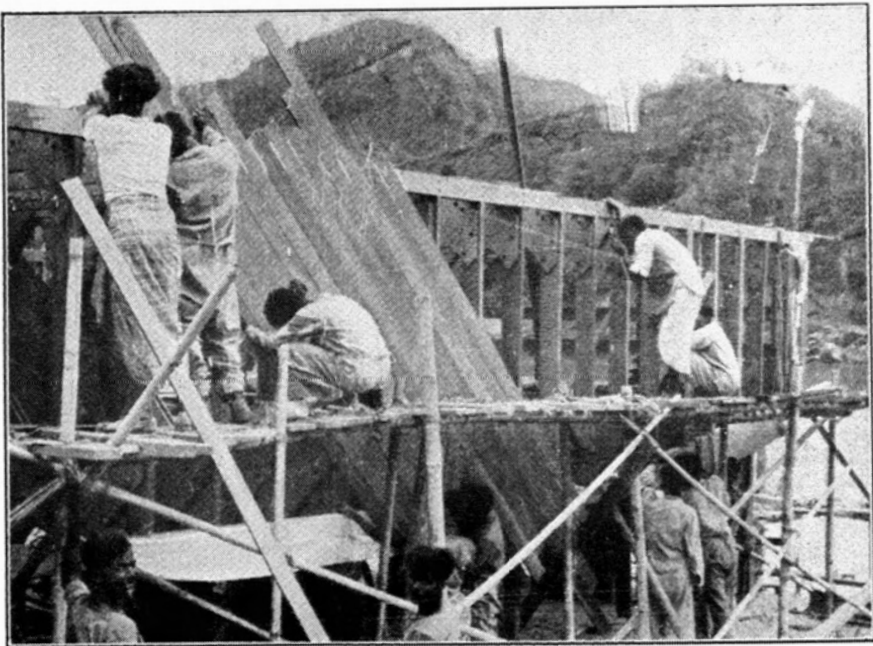
AT WORK ON THE SIDE PLANKING

On March 13th a start was made on planking the first boat. After great argument the planking was thickened and the edges planed true. The inner skin was tacked on with light wire nails. A bale of calico which had been soaking in a drum of raw linseed oil overnight was found burnt in the morning. At first sabotage was suspected, but when this happened on another occasion, it was decided that it must be due to spontaneous combustion. The galvanised permanent fastenings went through both skins and into the frames.

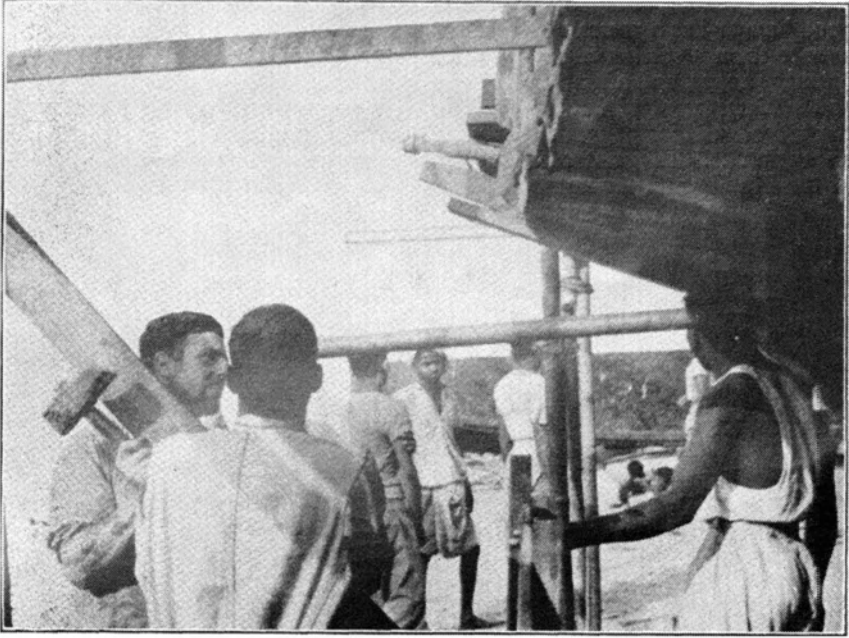
THE AUTHOR FITTING A STERN TUBE

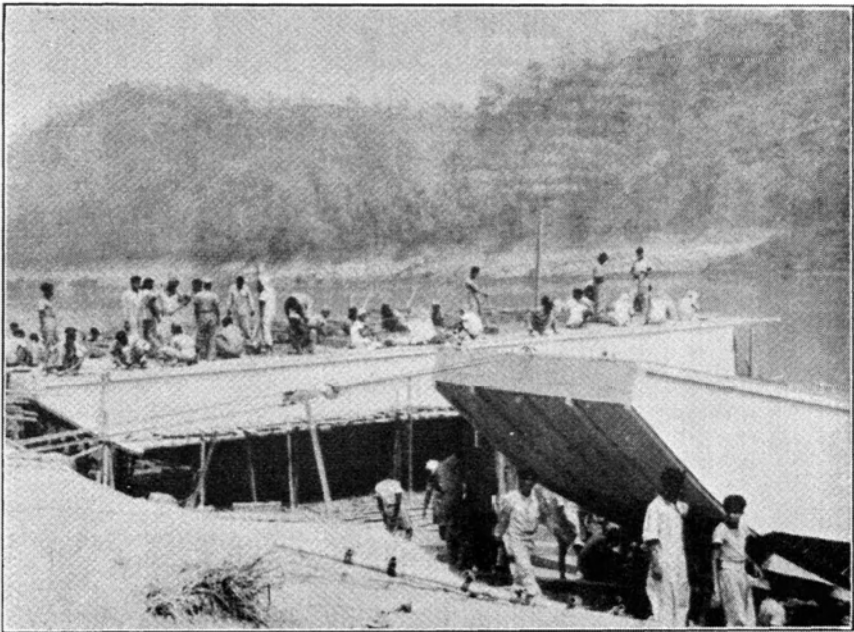
NOS. 1 AND 2 ALMOST READY FOR LAUNCHING

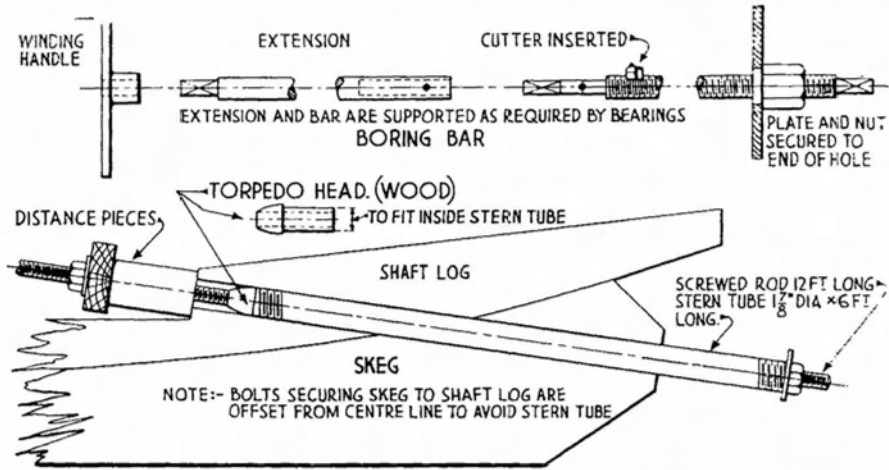
FIG. 1.—BORING BAR AND METHOD ADOPTED TO DRAW IN STERN TUBE

The next job was the final boring of the shaft logs and fitting of the stern tubes. The type of boring bar used is shown in Fig. 1. The bar was supported

at one end by the nut, through which it was screwed, the pitch determining the rate of feed. The other end was supported by bearings placed as advantageously as possible. The minimum unsupported length of bar was 6 ft., and often longer, as it was usually impossible to get a bearing right at the in-board end of the table. The bearing being only 1 in. in diameter meant that there was bound to be whip and chatter, so the whole operation was very hit or miss. It was a slow and tedious operation, as the thread on the nut was very fine, necessitating a vast number of turns to screw the cutter out of the hole. Many stops were also caused by obstructions in way of the winding handle as it moved along on the end of the bar. The method adopted for drawing in the stern tube with the aid of a long screwed rod 12 ft. long is also shown in Fig. 1, the tube being well greased and fitted with a 'torpedo head' as shown in the sketch. The assistance of a flogging hammer and a 5-ton jack was also necessary on occasion (see illustration on page 47). The outboard holes were drilled after the bottom planking was in place, this being necessary owing to the design of the shaft logs and skegs. Setting the bearings for the boring bar from a string stretched through the centre hole would have been a reasonably easy job if all the holes were parallel, but was complicated due to the holes being neither parallel, in a horizontal or vertical plane. Owing to the faulty shoring of the chines, the transoms and bottoms of the boats had hogged transversely; this meant a big difference between the shaft lines of wing and centre shafts. Needless to say, quantities of nails were found in way of the shaft lines, which entailed the removal of the skegs on several occasions.

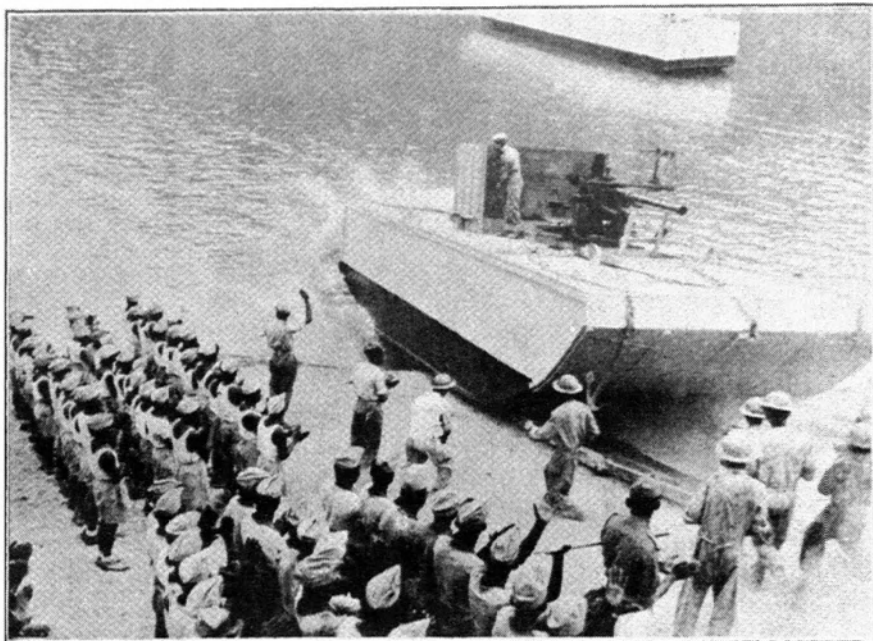
LAUNCH OF "PAMELA"

On April 9th the first two boats were launched by General Slim, being named *Una* and *Pamela* after his own and Supremo's daughters. Unfortunately neither of the daughters were there to see the launch. General Slim complained of the bluntness of the kukri supplied to cut the securing rope. The first boat stuck on the ways, but was got moving by a push from a large number of pioneers, already mustered nearby against such an emergency. Once under way, the launch was perfect. The rope holding the other boat also took much cutting, and the latter also had to be pushed. This one unfortunately crabbed sideways as it neared the water, tearing off a bit of the lower rubbing strake and damaging a propeller. Both were anchored in midstream, and were later brought alongside the fitting out jetty which had been built.

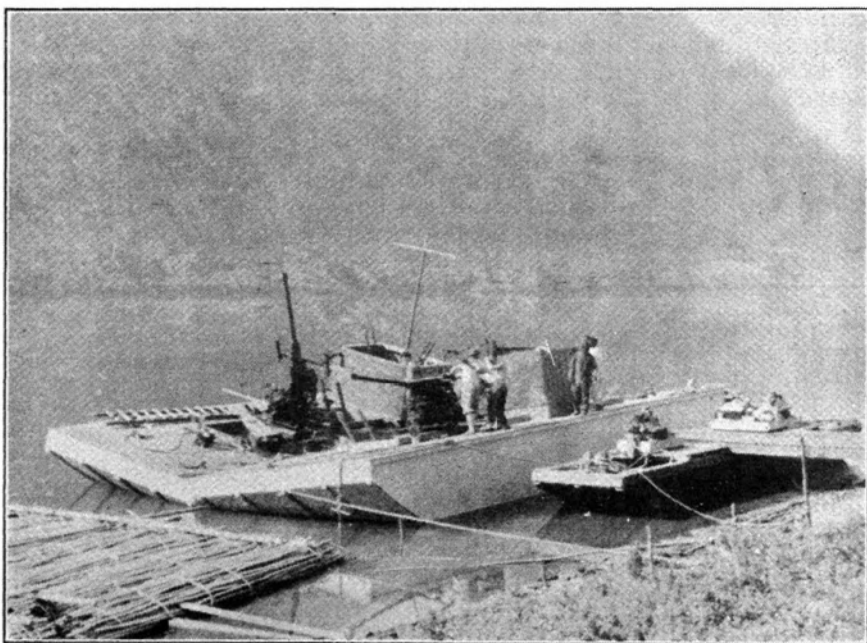
THE MORNING AFTER THE LAUNCH

The next day, both boats were found to be practically full of water and sinking rapidly (see illustration on page 50). The small army pattern motor pumps having broken down, the boats had to be baled out by a large party of pioneers and the worst leaks, due mostly to nail holes from which the nails had been withdrawn, were blocked up. It was decided to leave the boats for two days in order to let them 'take up,' meanwhile a welcome holiday was declared.
