OPERATIONAL EXPERIENCE WITH MEDIUM SPEED DIESEL ENGINES

Commander K. I. Short, O.B.E., D.S.C., R.N.,
C.Eng., M.I.Mar.E.*

The philosophy leading to the adoption of geared medium speed Diesel engines in a cargo liner and a products carrier is described and results obtained in service are presented and discussed against this background. The importance of considering a wide range of factors in addition to purely technical considerations in selecting and judging the performance of equipment is emphasized.

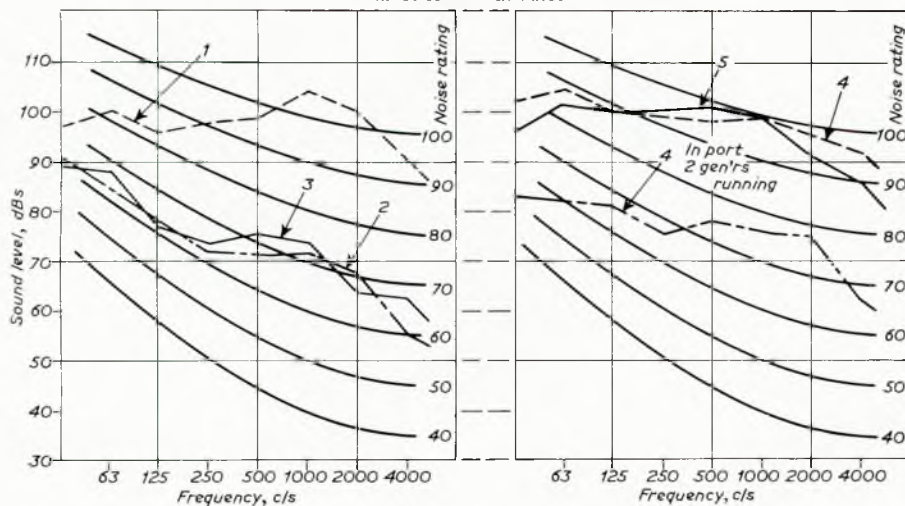
Representative engine room noise readings recorded in the cargo liner are shown in Fig. 2.

Note: Sound levels are those at sea with main engines at full power and three generators running, unless stated otherwise

FIG. 2—Machinery space sound level

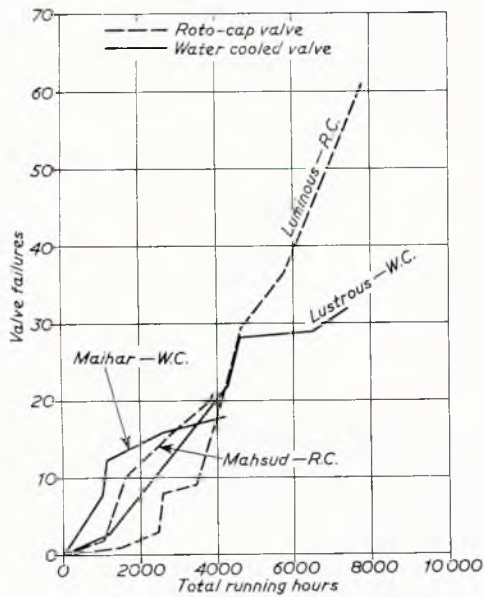
A graphical presentation of valve failures plotted against running hours is shown in Fig. 8.

FIG. 8—Valve failures reported—all causes

From Fig. 8 in the author's paper which related exhaust valve failures to engine hours the number of valve failures in either *Luminous* or *Lustrous* was 28 after 5000 hours. There were 48 exhaust valves in each ship. The vessel with four 9-cylinder 2-stroke medium speed engines suffered only seven exhaust valve failures after the same running hours, although there were three times the number of exhaust valves as on *Luminous* or *Lustrous*. This low level of exhaust valve failure rate was achieved using valves which were neither water-cooled nor fitted with rotorcaps and the average interval between overhaul was 3500 hours. No fuel additives were used. The owner now intended to increase the viscosity of the fuel bunkered, and it was expected the average vanadium content would rise to around 250 ppm.

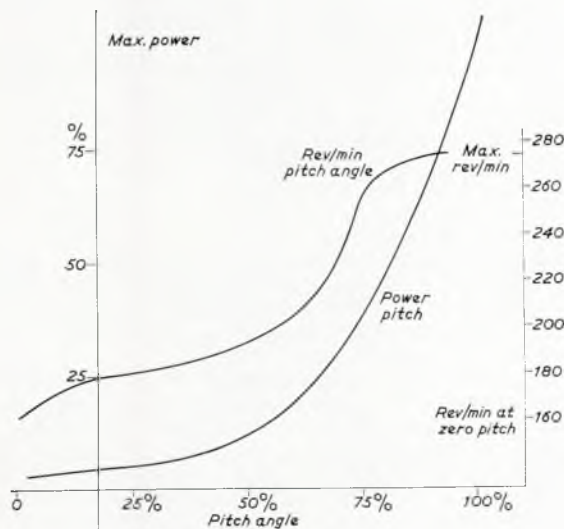
FIG. 11

The curve (Fig. 11) was derived from the first series and based on the selection of an idling speed coupled with a simultaneous increase of pitch and speed.

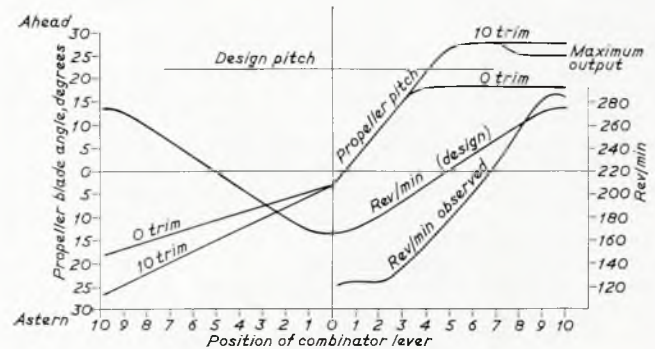
FIG. 12

Fig. 12 was a characteristic combined diagram and related specifically to the original pattern of control built into a twin screw ship propelled by two engines per shaft and also in a number of similar ships operated by the same company. The second of each pair of engines developed half the power of the first and the total power developed was 5800 bhp/shaft in engines of substantially lower rating than those being discussed by the author. The linear pitch changing rate of 12 s (i.e. full ahead pitch—full astern pitch) represented a mean rate of power change of approximately 16 per cent/s, but due to the gradients of the power curve the spread was in the order of 4 per cent/s at the low output end up to in excess of 35 per cent/s at the approach to full power. It was interesting to note that the published accelerating rates of advanced steam and nuclear plant were in the region of 1-4 per cent/s. This instant power would no doubt appeal to the swashbuckling attitudes of R.N. and M.N. bridge officers but it certainly did not endear itself to the average engineer officer. The machinery was commissioned after the normal type of trials where torque and maximum cylinder pressures were measured in the usual way at the steady state in several increments up to full power.

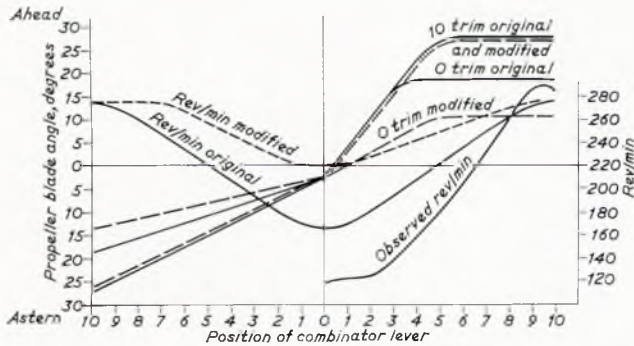
FIG. 13

larly relevant since the ship spent about a quarter of its time in the manoeuvring mode. Another relevant point was that the continued lifting of relief valves, where fitted, was not a requisite to excessive cylinder pressures. Small uncooled relief valves, as well as being vulnerable to complete choking, could be very troublesome, and the usual setting of about 18 per cent above the maximum designed combustion pressure might unwittingly be exceeded by an already overworked engineer officer. Following some years of operation associated with piston skirt scuffing and roughening of the cylinder liners and culminating in piston seizures and two violent crankcase explosions, the control system was redesigned on the basis of this modified combined diagram which had been superimposed on the previous diagram (Fig. 13).

It would be noted that the idling revs had been lifted from the observed 125 rev/min to 220 rev/min and that the slope of the pitch changing rate had been reduced considerably at the position of zero trim. The effect of these modifications was to increase the blower speed at idling from 2000 rev/min to 4000 rev/min and provide a positive charge air pressure. Manoeuvring was carried out in the usual way with a trim setting of four and a marked absence of blower surge and black exhaust which obtained previously. Acceleration was smoother but the position of the fuel rack was still noted to be held in advance of its full power position during the approach to full power and during crash manoeuvres. Rather than reduce the pitch trimming value in an arbitrary manner, it was decided to attempt to use a piezo-electric transducer to monitor the transient behaviour during manoeuvring.

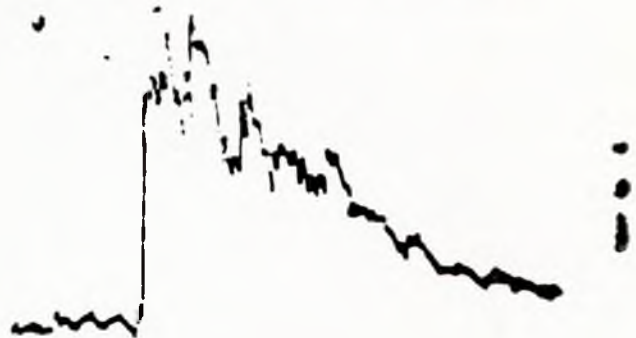
FIG. 16—Fuel line—no unloading

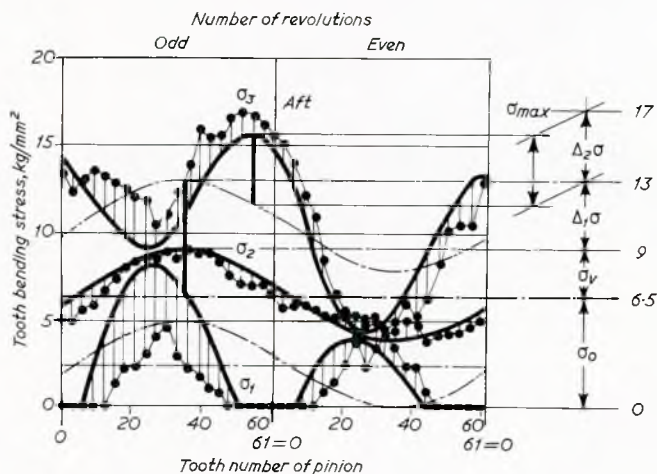
Application of the unequal stress distribution method revealed that there were irregularities. Condensed from a larger number of revolutions, Fig. 19 showed the variation of tooth

FIG. 19—Unequal bending stresses during two pinion revolutions

bending stresses during two pinion revolutions σ_1 , at the forward end, σ_2 at the centre, σ_3 at the aft end. The points were the values measured and the solid lines an attempt to analyse their tendency by the super-position of the sine curves, in a simplified manner. The average of σ_2 in the centre was the normal stress $\sigma_0 = 6.5$ kg/mm², produced by the mean torque of the engine. A vibratory stress $\sigma_v = 2.5$ kg/mm² was superimposed, as indicated by the long wave sine curve with a period of two pinion revolutions, due to 0.5 order engine torque vibrations. At equal stress distribution, curves σ_1 and σ_3 would be the same as σ_2 . But σ_3 appeared at a higher, σ_1 at a lower level, as outlined by the sine curves parallel to the σ_2 curve. This was an indication of a non-variable component of unequal stress distribution, due to non-parallel shafts or misalignment. Tooth bending stresses were increased at the aft end and decreased at the forward end by $\Delta_1\sigma = 4$ kg/mm².

Dr. Pinnekamp said it should be mentioned that the diagram did not represent the full load condition. It had been chosen because it was more instructive. At full load, a normal stress of $\sigma_0 = 15$ kg/mm² was measured, and the maximum stress at the aft end amounted to as much as $\sigma_{max} = 43$ kg/mm². Thus, by accumulation of additional stresses caused by excessive misalignment and excessive tumbling, the gear had eventually failed by fatigue.

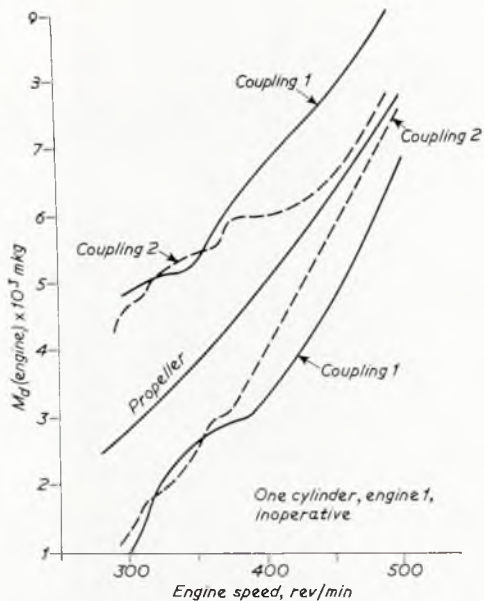
FIG. 25—Alternating moments over the propeller curve

First, as they normally used torsionally elastic couplings, the calculation of vibration was of vital interest. In most cases it was possible to avoid resonance between natural frequency and excitation by the Diesel engine, at least by adaptation of the elasticity of the rubber elements. Their experience, however, led to the necessity of calculating not only the vibration situation of the system running under proper conditions but also under the possible condition that one of the cylinders did not contribute to the power generation. In this case the alternating torque could increase to an amount which could easily damage the coupling, gears or even shafts. This was the reason why they recommended (and it was also their own practice) the calculation of torsional vibrations also under abnormal conditions. The choice of coupling elements, their elasticity and their dampening properties had then to comply even with these most unfavourable running conditions (see Fig. 25).

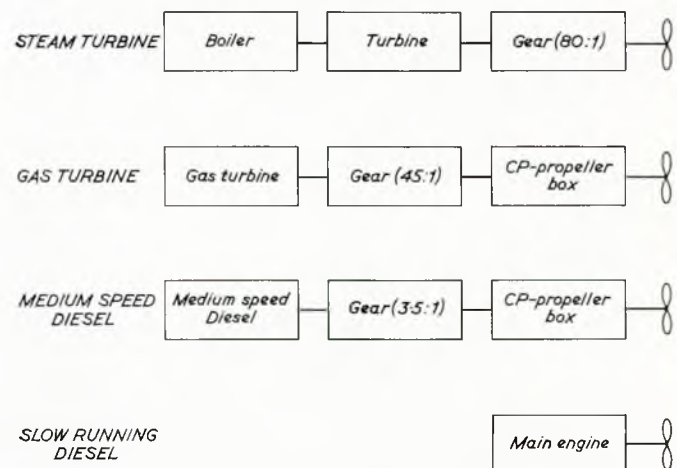
FIG. 33—Main components for different propulsion machinery

MR. J. BERRING, A.M.I.Mar.E., said that this paper was of great interest to his company and had resulted in a comparison with their own results and experience. He did not quite agree with the introduction, regarding the advantages of medium and slow speed engines. If, for instance, the ability to proceed under own power in case of a breakdown was considered, there was the following range of propulsion machinery available (see Fig. 33)

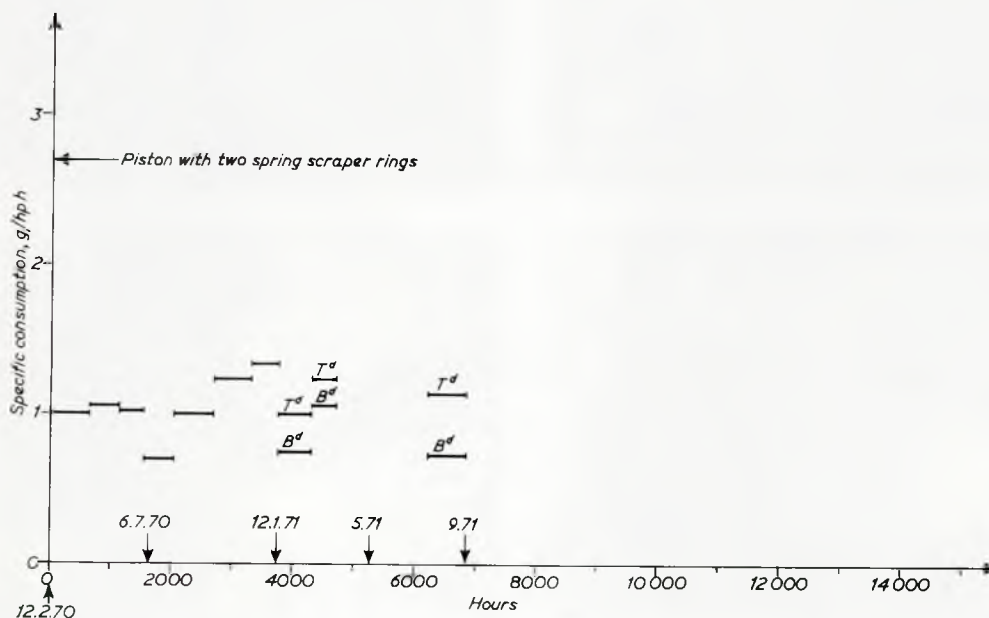
FIG. 36—Specific lubricating oil consumption against running hours of two 18PC2V engines equipped with pistons using two spring-loaded scraper rings

Fig. 36 showed the results obtained with the first ship equipped with these rings. She was *Pointe Marin* of the French line and, after 7000 running hours, the port engine gave 1.2 g/hp h and the starboard engine 0.7 g/hp h. The owner gave these figures. In this particular ship they used the engine at constant speed and also in the port whilst unloading, as the author did with ships of the *Luminous* type.
