A Practical Ultrasonic Inspection Method for Detecting and Characterising Defects Found Within Composite Repairs

Co-Authored by: J.Downing BEng (Hons) MSc DipIC CEng MIMechE and A.Hook BSc (Hons) AMRINA

Synopsis

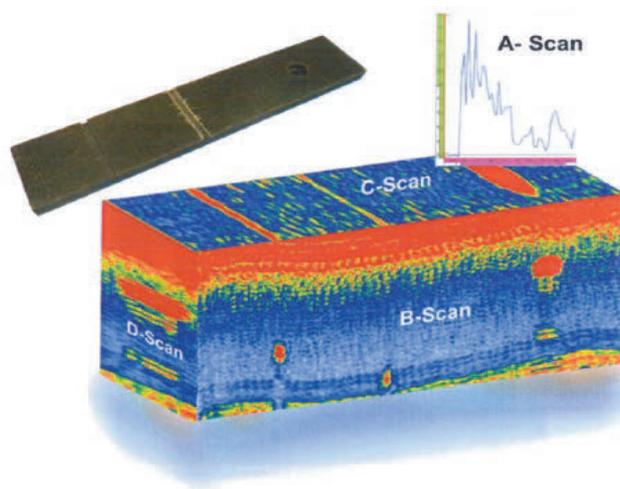
Figure 1 – PA Analysis Software of CFRP Calibration Piece

Once the scan is complete, data is exported to TomoView[®] analysis software, which allows production of four image types (A-, B-, C- and D-Scans) that can be manipulated into a 3D image (Figure 1) or analysed in slices. Data can be permanently stored, allowing comparison against the historical state of the structure.

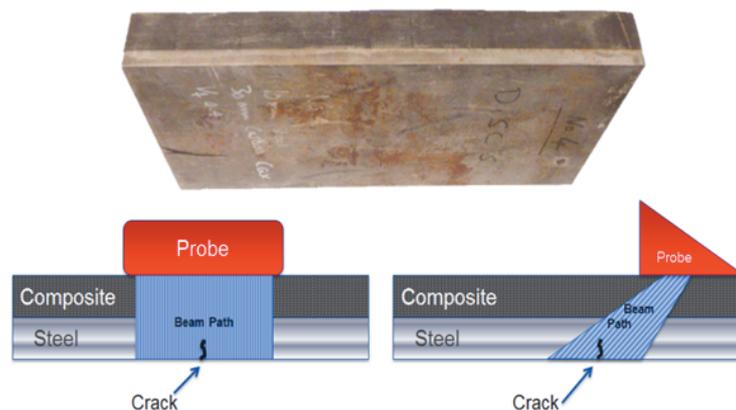
Figure 2 – Shear Waves to Detect Cracks

As no standard exists for the identification of fatigue cracking type flaws it was decided that the simulated flaws should be parallel with regards to the PAUT technique used for detection, i.e. cracking at a 0° angle with respect to the PA beam. This represents the most difficult to detect flaw as the PAUT technique primarily uses a 0° compressional beam that will identify the smallest plan surface area of the crack. If the crack is hit at an angle using shear waves (illustrated by Figure 2) it will provide a surface area greater than the 2.925mm and 1.535mm smallest detectable flaws as expressed by Equation [1], hence the potential to identify this flaw type would increase.

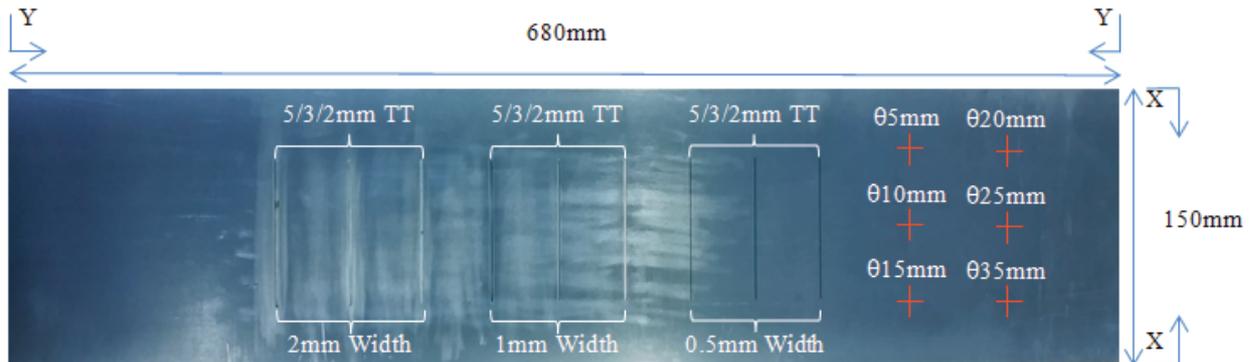
Figure 3 – Test Piece 1

- Steel substrate cracks – 9 spark eroded slotted flaws of varying widths and through thicknesses, perpendicular to the scanning interface (Figure 3 – Test Piece 1):
 - 2mm to 0.5mm wide.

- Recessed depths ranged from 2mm to 5mm, allowing inspection sensitivity to be measured from 20% to 50% of the 10mm steel plate thickness.
- De-bonding between the bonded CFRP to steel interface – 6 Polytetrafluoroethylene (PTFE) disk inserts of varying diameters, each 0.25mm thick (Figure 3 – Test Piece 1).
- Steel substrate loss of wall thickness – 35 milled circular flaws of varying diameters and recessed depths (Figure 4 – Piece 2):
 - Circular areas (30mm to 2.5mm diameter).
 - Recessed depths ranged from 0.1mm to 5mm, allowing inspection sensitivity to be measured from 1% to 50% of the 10mm steel plate thickness.

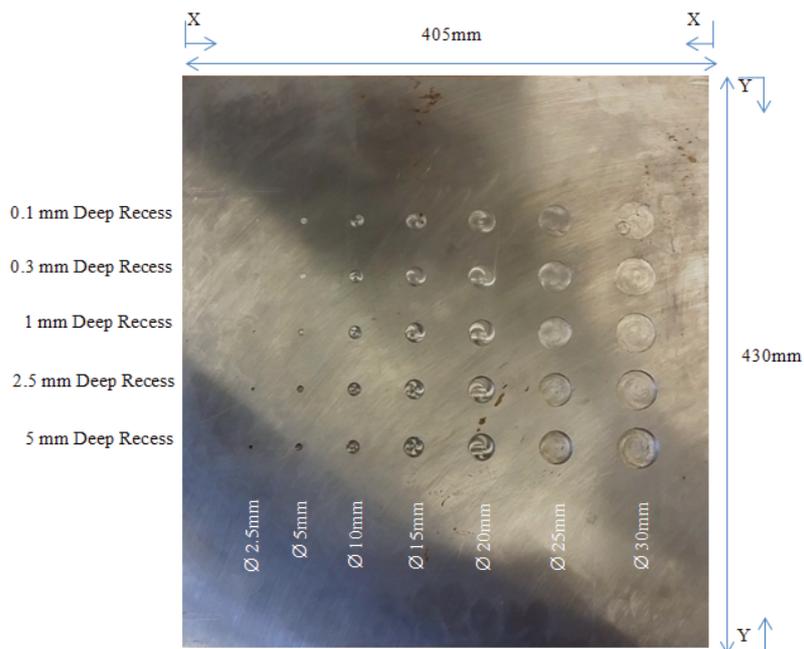
Figure 4 – Test Piece 2

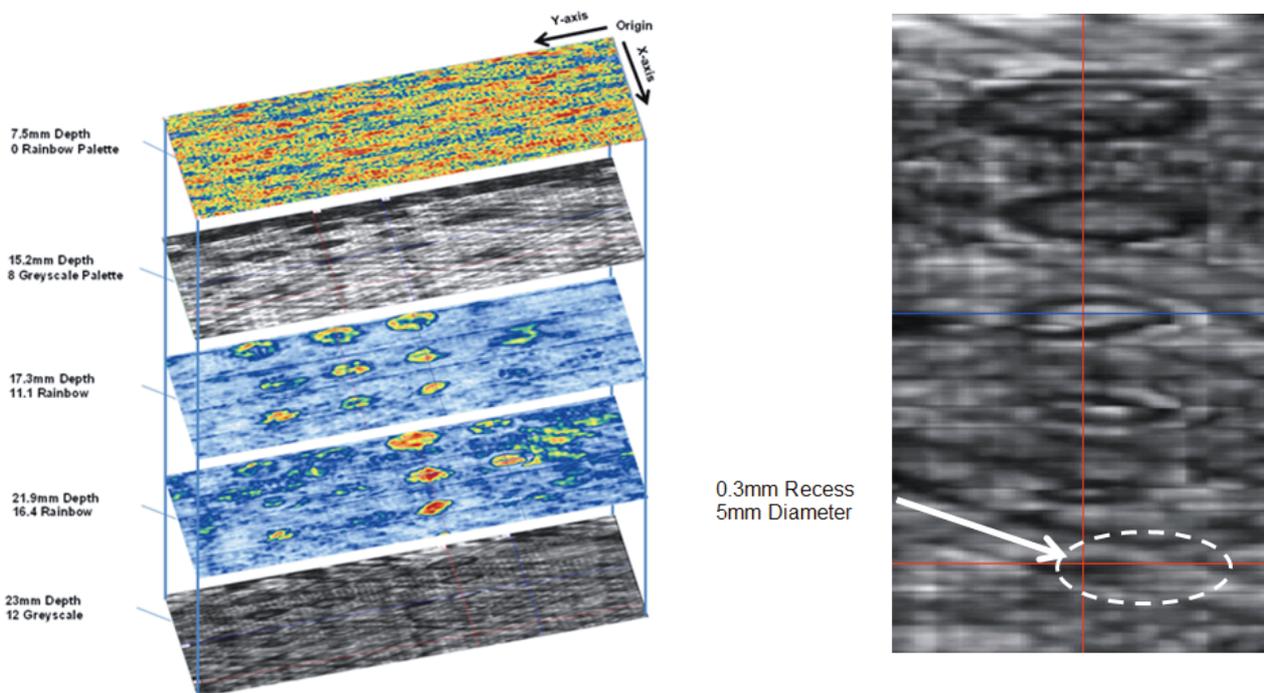
Figure 5 (Left) – L1.5: Test Piece 2 – 5MHz Roller Scanner – 10mm Focal Depth
Figure 6 (Right) – L1.5 Single Plane C-scan at 23mm Depth (Greyscale Palette = 12)

The ensuing key images (*Figure 5 to Figure 11*) were extrapolated from TomoView® to illustrate the minimum flaw detection characteristics highlighted in Table 4, i.e. L1.5, L1.7.2 and L2.2. The C-scan slices are stacked and oriented into one image to show all detected flaws at their given depths, with palette type and contrast/exposure level also specified.

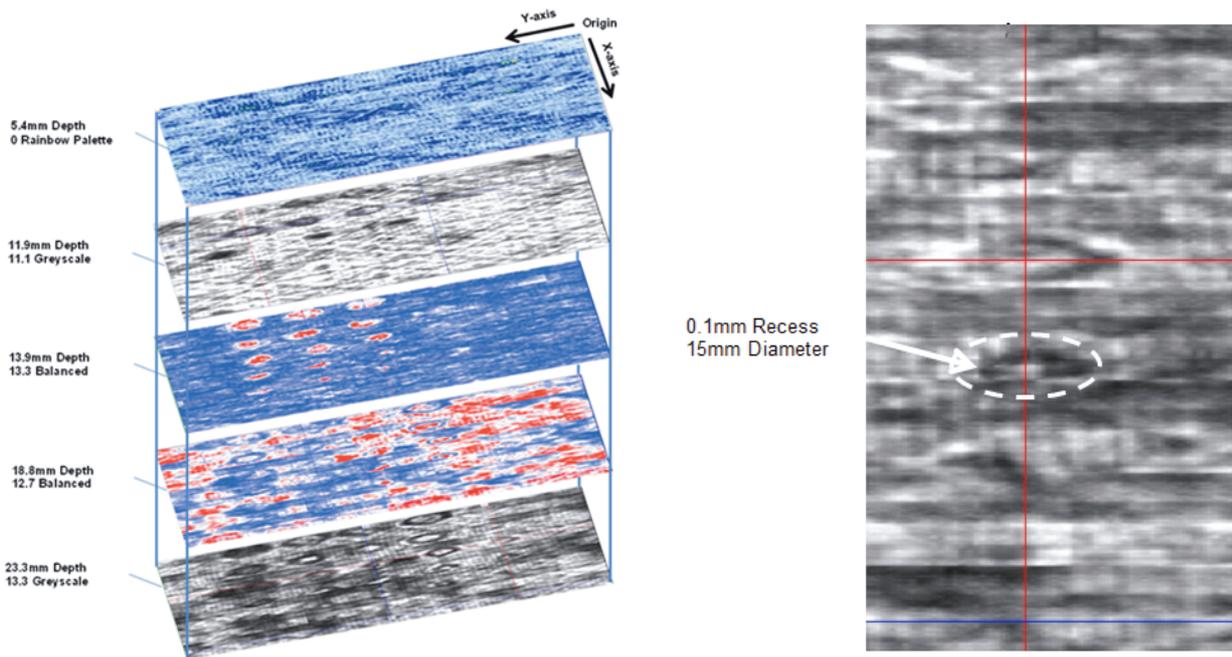
Figure 7 (Left) – L1.7.2: Test Piece 2 – 5MHz (BP 2) Roller Scanner – 15mm FD
Figure 8 (Right) – L1.7.2 Single Plane C-scan at 23.3mm Depth (Greyscale Palette = 13.3)

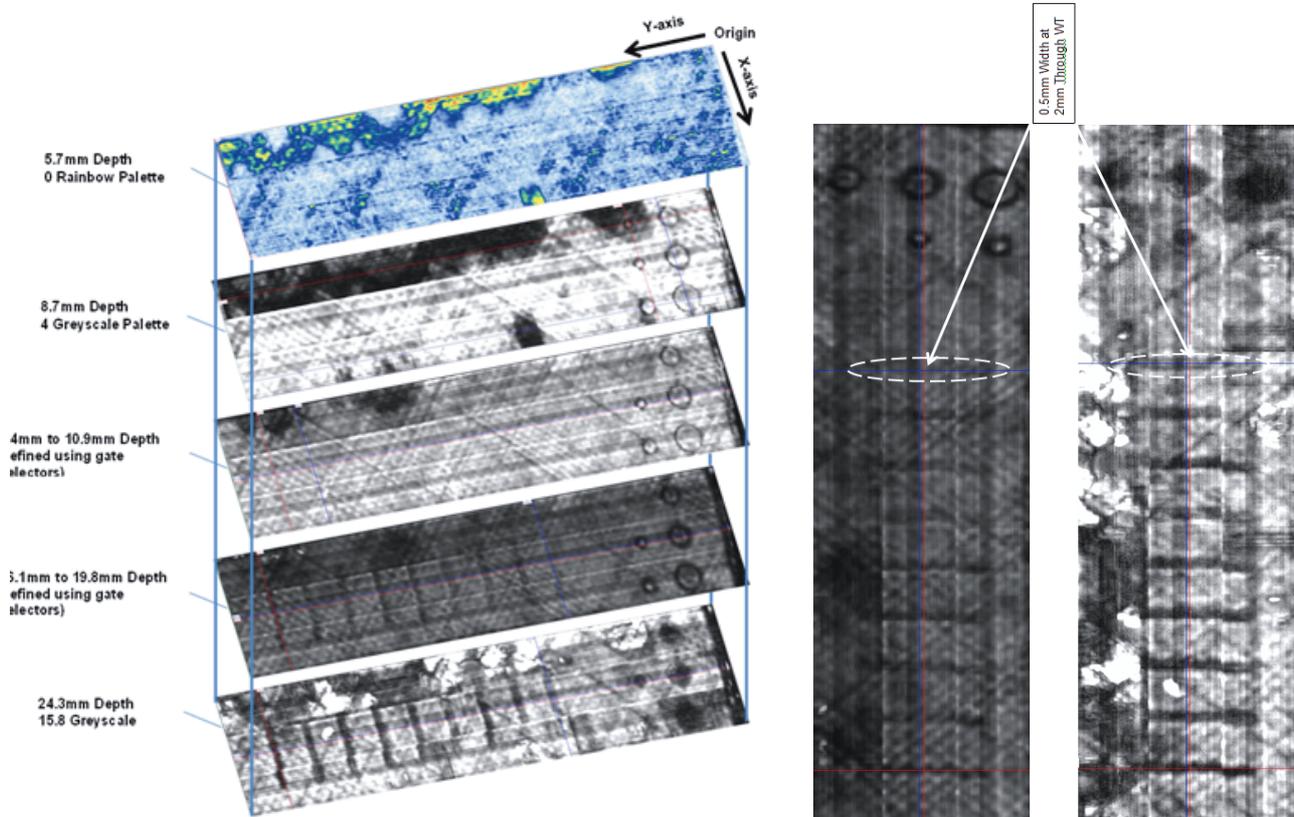
Figure 9 (Left) – L2.2: Test Piece 1 – 5MHz Roller Scanner
Figure 10 (Middle) – L2.2 Single Plane C-scan at 16.1mm to 19.8mm Gate Selector Refined Depth Range
Figure 11 (Right) – L2.2 Single Plane C-scan at 24.3mm Depth Range

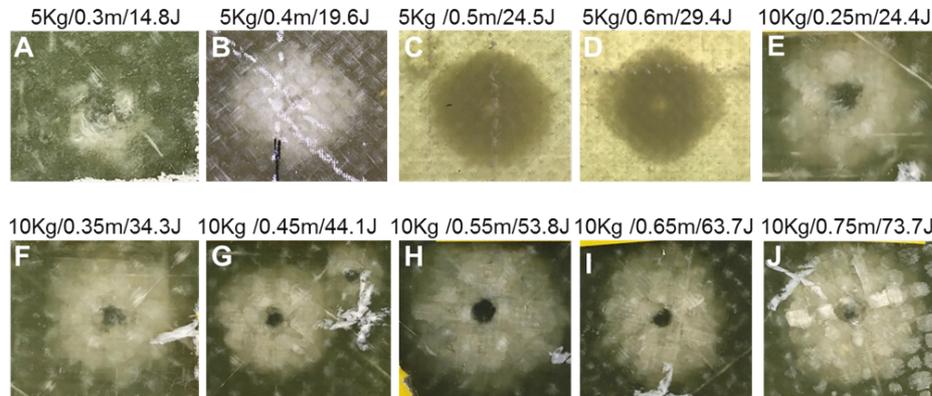
Figure 12 – Impact Test Samples A-J

From an initial visual inspection, Sample-A in Figure 12 shows Barely Visible Impact Damage (BVID) with no signs of de-lamination, whereas samples C and D when held up to the light show significant damage and visual signs of multilayer de-laminations. Samples I and J show surface and back surface rupture and a sign of potential fibre breakout.

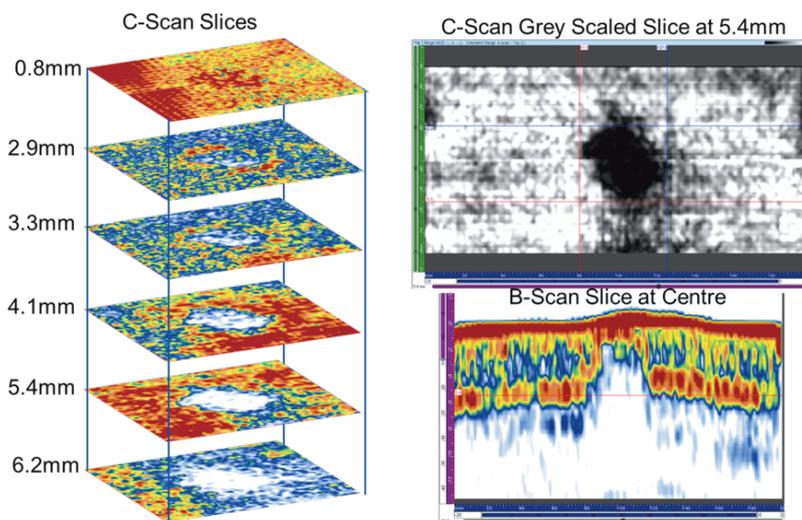
Figure 13 – Sample D (KE $\approx 29J$) Exploded C-scan, B-scan and Grey Scale

Sample A, which has the lowest impact energy ($\approx 15J$), had a maximum flaw width of 12mm at the back wall echo and first detection of the flaw at 5mm deep. Sample D (Figure 13) has a relatively medium level of impact energy ($\approx 29J$) and had a maximum flaw width of 67mm and first detection of the flaw at 0.8mm. Sample J has the highest impact energy ($\approx 79J$) and had a maximum flaw width of 60mm and first detection of the flaw at 0.4mm.

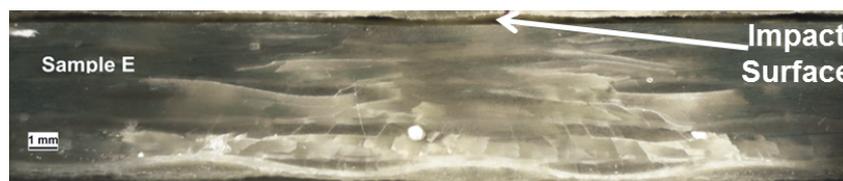
Figure 14 – Optical Results 6.3x Magnification Impact Sample E - Macro Slice Side on View

All the impacted samples were subjected to optical microscopy with an example of a macro slice (Sample E) shown in Figure 14. Sample E revealed multiple layers of matrix cracking and multiple planar cracks. The planar thin white surface cracks have been identified as non-symmetrical fine de-laminations between two plies. This result was indicative of the majority of samples (B-J).

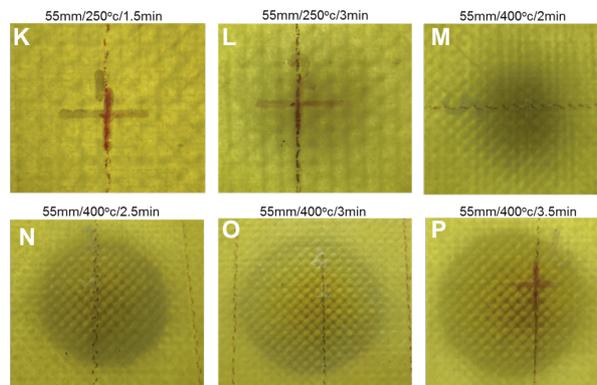
Figure 15 – Heat Exposure Test Samples K-P

The visual results of the heat exposures can be seen in Figure 15.

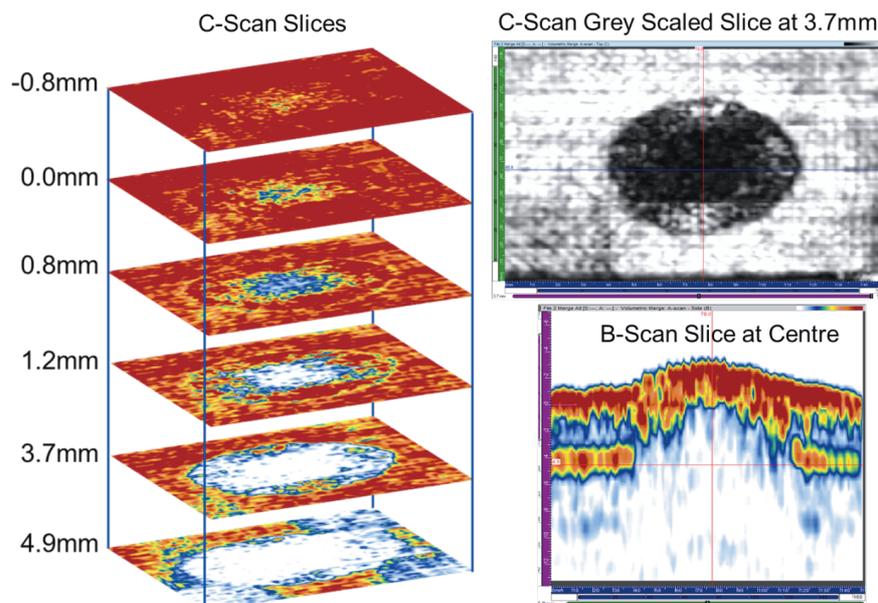
Figure 16 – Sample O (400°C 3min) Exploded C-scan, B-scan and Grey Scale

Sample O had the largest de-lamination and had 400°C of concentrated heat applied to it at distance of 55mm for 180 seconds. The C-Scan slices, which begin with a negative depth due to the proud blister, can be seen in Figure 16.

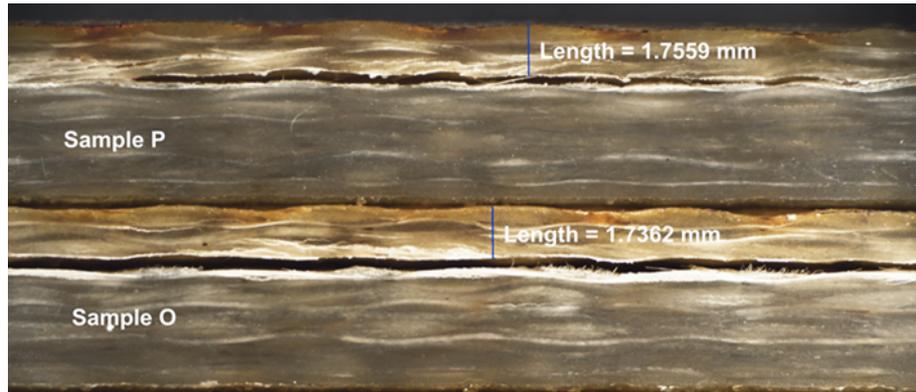
Figure 17 – Heat Exposure Samples - Optical Results – Macro Slice Side on View

The samples that were exposed to 400°C for durations of 150 seconds and greater (N, O and P), have symmetrically round surface blisters and surface scorching, which has caused significant subsurface de-laminations. The de-laminations have a width of 62-75mm and a near surface depth of approximately 1.7mm, as shown in Figure 17.

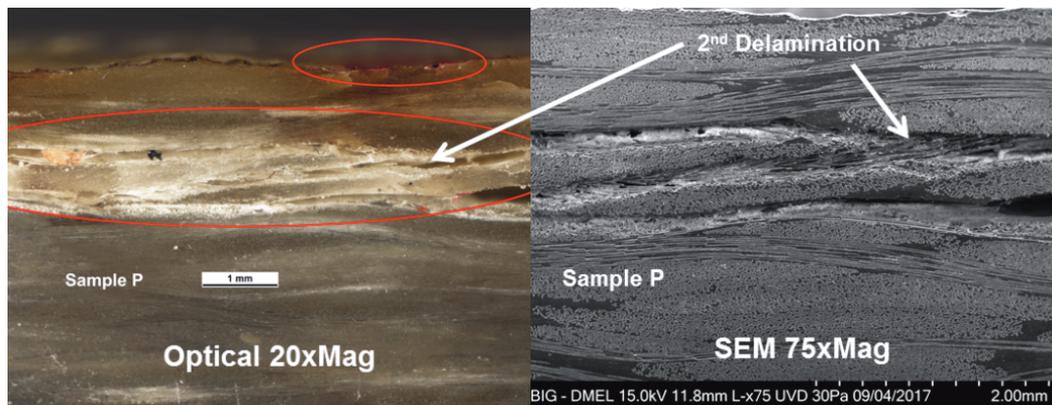
Figure 18 – Sample P - 2nd De-lamination SEM Confirmation

There were some artefacts/indications in the optical microscopy results, which could not be qualitatively determined and characterised, and thus were subjected to a scanning electron microscope for further identification. Figure 18 (left Image) shows an area at the edge of a large de-lamination with ambiguity as to what the visual damage is. The SEM (Figure 18 – right image) clarified it as multiple smaller near surface de-laminations as well as fibre breakage.

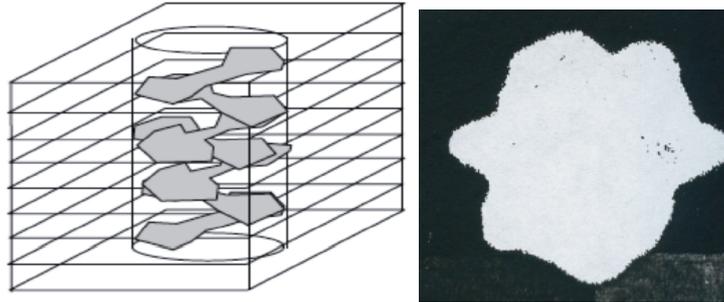
Figure 19 – Layers of Impact De-laminations Formed in Laminate, Morton (p.75-76) © Imperial College London

There is a distinct difference between the PAUT scan of a significant delamination and a sample that has matrix cracking and fine planar horizontal crack/de-laminations. The horizontal cracks seen in the volumetric slices of the impact Samples A-J are layers of fine one ply irregular shaped de-laminations, as seen in Figure 19 (Left) (p.75-76). If the layers of de-laminations were looked upon in a plan view (C-Scan) they would appear as an outline of all the de-laminations stacked on top of each other, as seen in Figure 19 (Right) (p.75-76). This outline is the unique trace of multi-layered matrix cracking/de-laminations that can be seen in the sliced C-scans from the PAUT scans taken from the samples in this study.
