MAIN GEARING INSPECTION, ALIGNMENT, AND MAINTENANCE

COMMANDER (E) J. H. JOUGHIN, D.S.C., R.N.,
Engineer-in-Chief's Department

The following notes on main gearing are intended to provide a background of facts and experience so that when main gearing is inspected, either as a routine or after damage, a broadly based appreciation may be formed with an enhanced confidence to decide the appropriate remedy, or supply the significant information in a report.

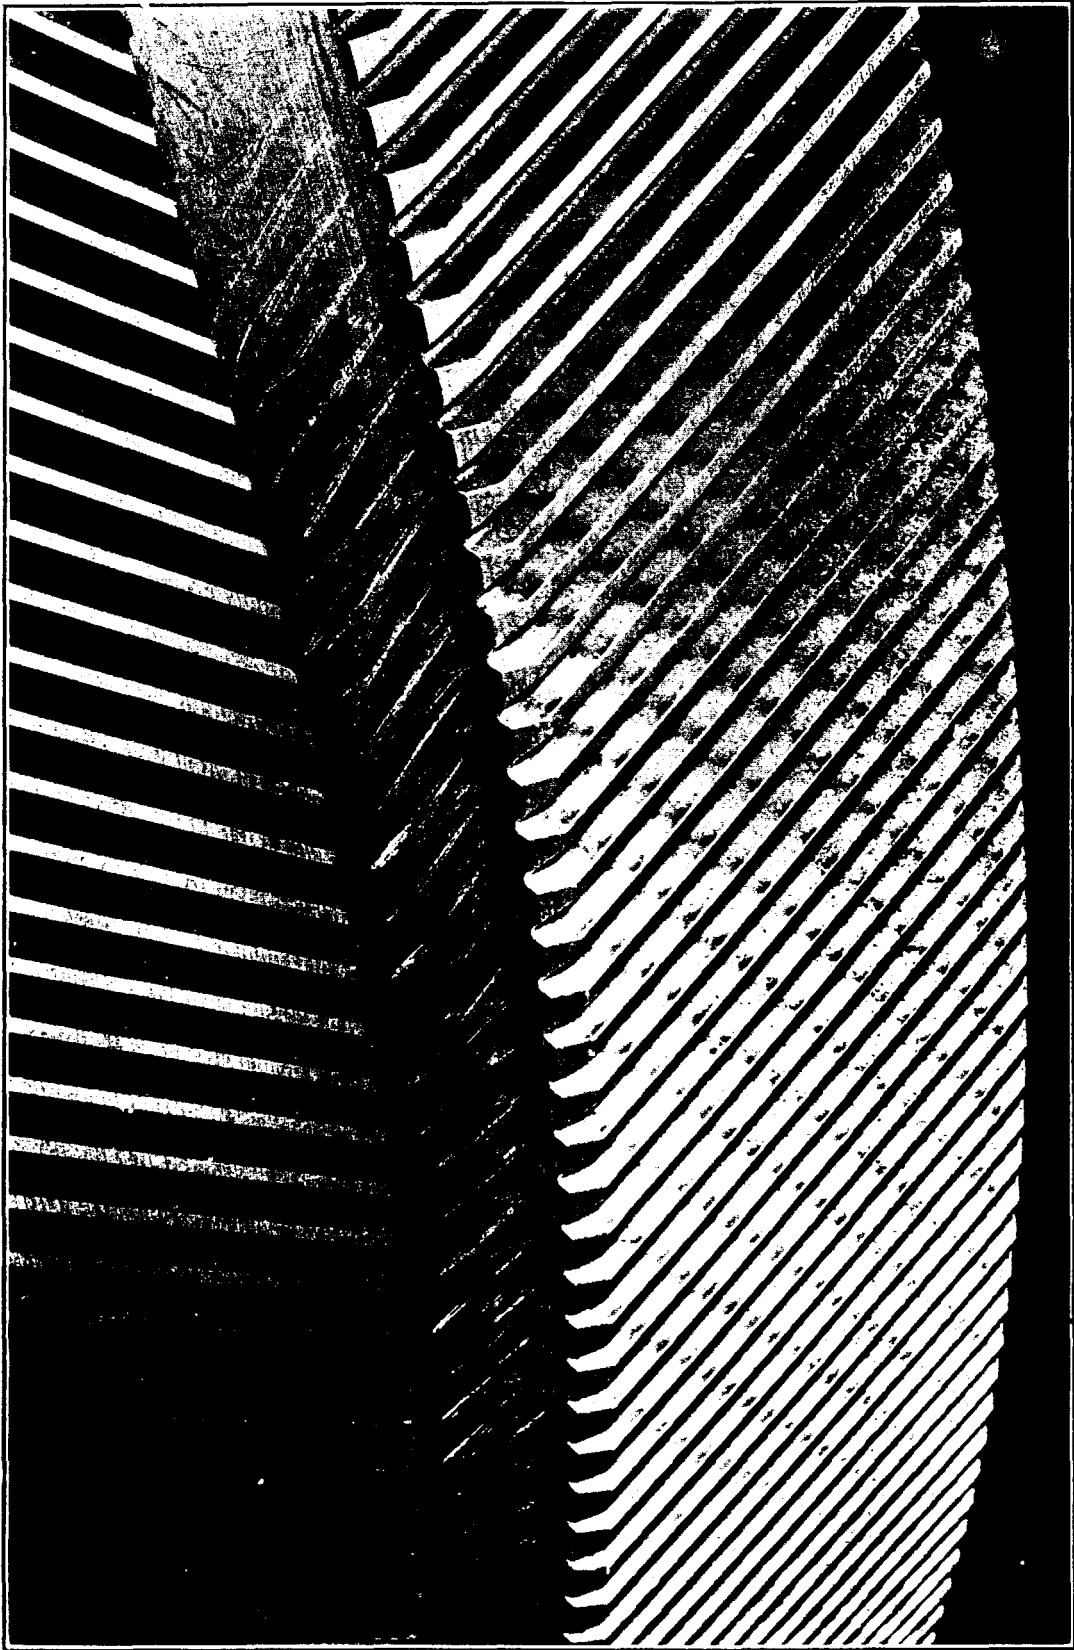
FIG. 7.—NON-CREEP ERROR

FIG. 7A.—NON-CREEP ERROR

Non-creep Error.—For gears cut on hobbing machines not fitted with creep gear an error may arise from the non-uniform motion of the worm-table drive, from the drive to the worm or from the worm abutments. This error, if at all marked, gives rise to a very severe noise concentrated in a single frequency (the frequency naturally varying with the speed of rotation). This single-frequency noise is more disturbing than a noise of similar volume composed of a number of frequencies. This error appears as a pattern of *axial* bands of marking on the wheel teeth (Figs. 7 & 7A). It may be noticed that it is also possible to draw diagonal lines through the hard spots but the important factor is the *axial* nature of the bands.
