NAVAL HELICOPTER ENGINES IN THE BEGINNING

REAR ADMIRAL M. F. SIMPSON, CB, CENG, FIMECHE, FRAES
(*Chairman Hunting Aviation, Aircraft-Engineering Division*)

ABSTRACT

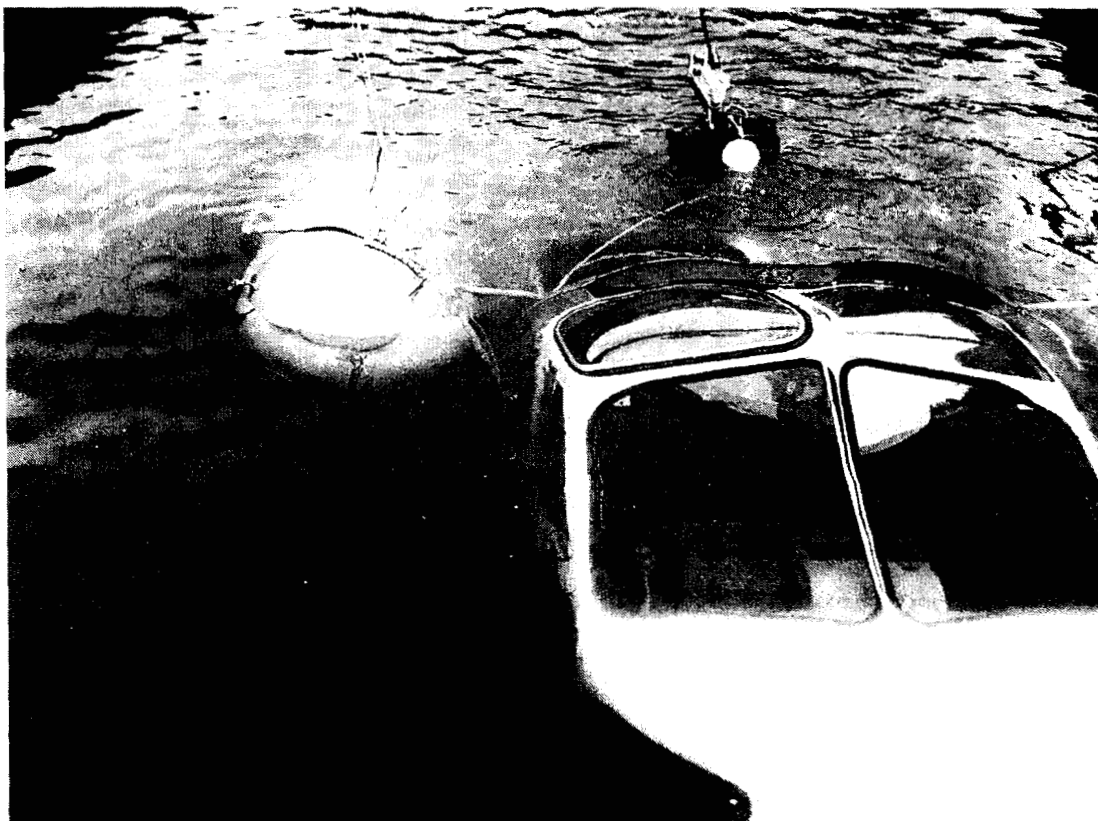
FIG. 4—DEVELOPMENT TRIALS OF WASP FLOTATION GEAR BY THE FAIREY AVIATION DIVISION OF WESTLAND AIRCRAFT, AT HAYES IN NOVEMBER 1964

The RN bought 98 WASPs, and by the early 1980s 24 had been lost, of which 14 were attributed to engine failure. In addition, 4 other engine failures caused accidents where the aircraft ditched, but were subsequently recovered. Had flotation gear not been available (FIG. 4) this would have given an engine induced attrition rate of 18%. The introduction of routine oil analysis in 1968 was responsible for detecting many impending engine failures, which helped to minimize further losses. This required a 365 day decisive service by the Naval Aircraft Materials Laboratory (NAML), which demonstrated a unique understanding of both the technical and operational priorities facing the WESSEX and WASP fleets.
