# H.M.S. 'AMAZON'

## THE BIRTH OF A GENERATION

Many teething troubles are inevitably associated with the introduction of a new machinery concept (COGOG) into the Fleet. This article recounts the problems that were experienced during the development of the engineered package. The solution of the various problems leading to the successful acceptance of H.M.S. *Amazon* shows that the design augurs well for the future of the Types 21, 42 and 22 Classes.

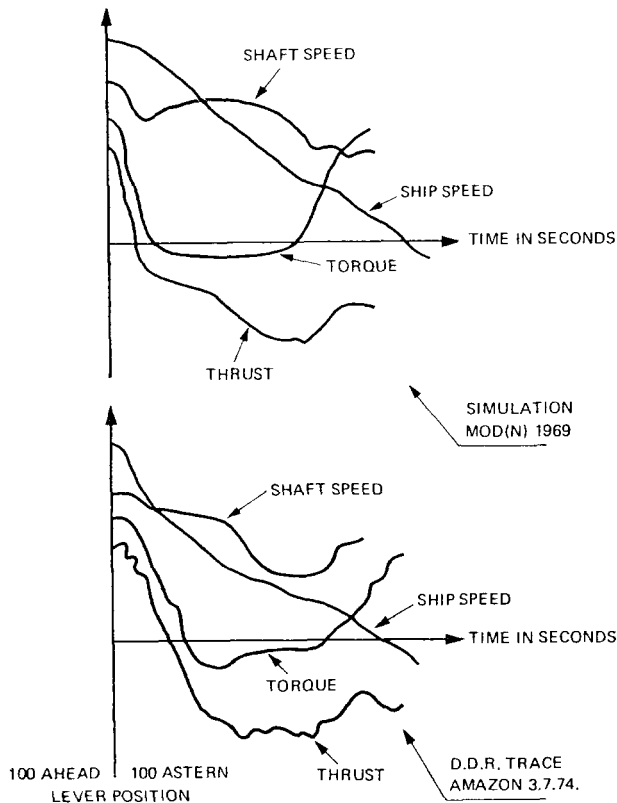
FIG. 8—COMPARISON OF MANOEUVRING TRACES

simulations undertaken in 1969 with the actual traces taken from the DDR unit five years later. FIG. 8 shows the extremely good correlation.

After a successful official basin trial, the ship sailed for sea trials on 24 June. The first two days at sea showed that the vibration in the high-speed line had been satisfactorily cured, and that the ship was now capable of full speed and full power and was ready for contractor's sea trials. The MCTT first checked the response of the control system including matching the engine fuel schedule to the requirements. This was not simple since the facility for screwdriver-type adjustment was not available (although this modification was incorporated later). The process was somewhat tedious as, after each adjustment, the trial had to be repeated; this, nevertheless, paid dividends as the parameters were set for the whole Class and very precise and repeatable control was achieved thereafter. It is interesting to compare the original computer manoeuvring
