# CHEMICAL CLEANING OF BOILERS AND FEED SYSTEMS

*The following article is an edited version of a report on the Chemical Cleaning of Boilers and Feed Systems carried out in H.M.S. Berwick. The report was originated by Lieutenant I. Brannan, B.A., Grad.I.Mech.E., who was loaned to H.M.S. Berwick while the work was in progress.*

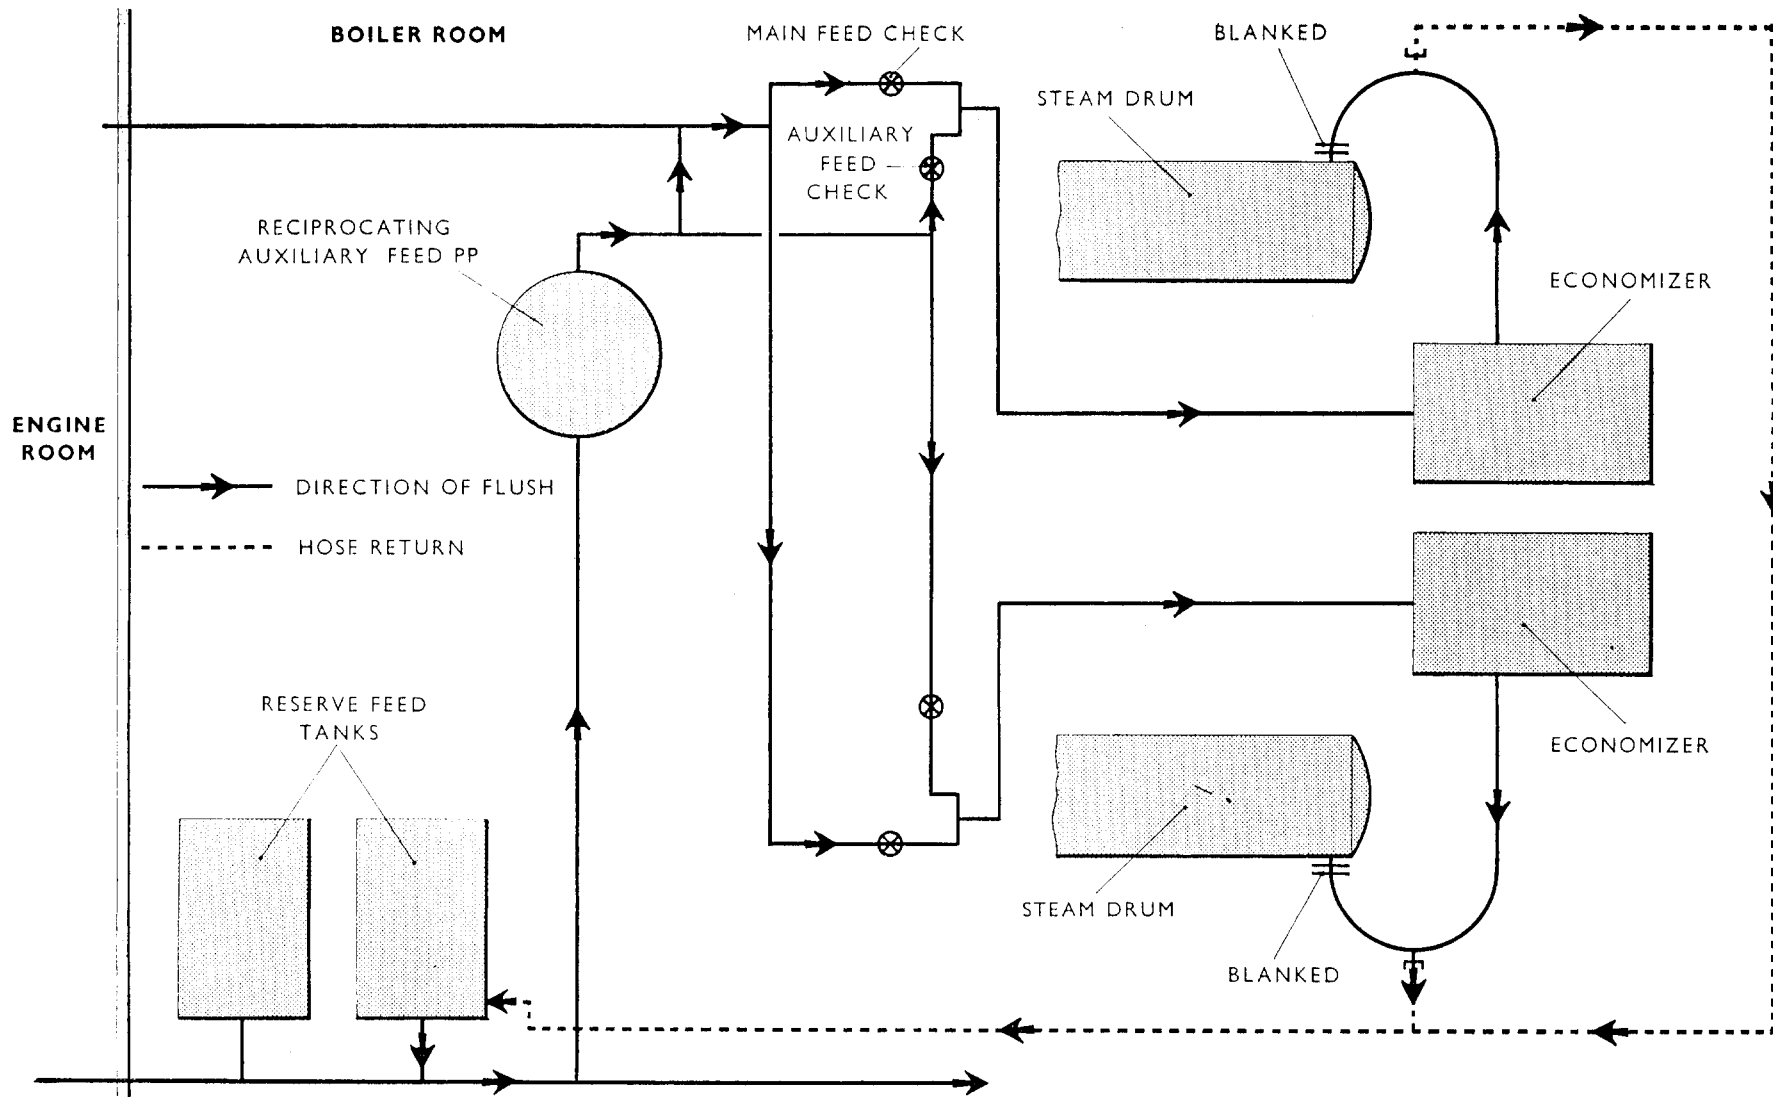
FIG. 3—FLUSHING OF BOILER ROOM SYSTEM

- (a) The reciprocating auxiliary feed pump was used to circulate degreasant fluid from a reserve feed tank previously degreased, through the main and auxiliary feed check valves and feed system, and through the economizers.
- (b) The feed water discharge from the economizers to the steam drum was broken and blanked, the economizer draining back to the reserve feed tank through the economizer drain hose connection. FIG. 3 shows a diagrammatic sketch of the system.
